Appendix E, Attachment H – Hydrology & Drainage – Assessment of Alternatives

East-West Arterial Extension:

Hydrology and Drainage FINAL

Assessment of Alternatives Grand Cayman East-West Arterial Extension

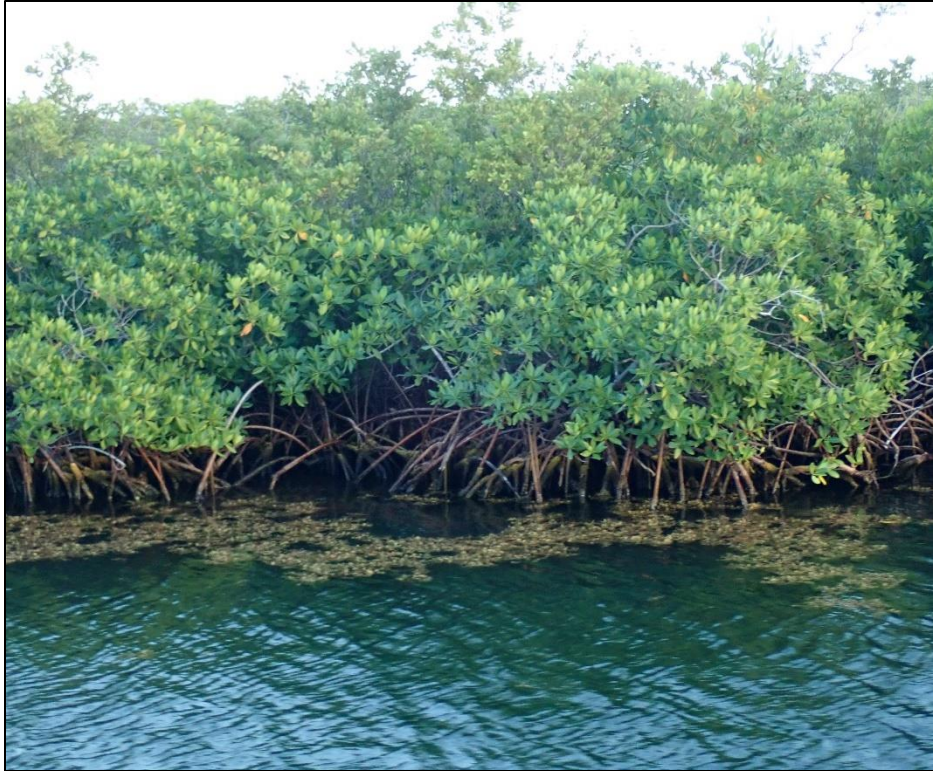
Figure 8: Mangroves along North Sound (February 2023)

Studies have shown that mangroves provide a natural protection from strong waves, acting as a natural buffer. It is estimated that an approximate 650-ft (200 m) width buffer of mangroves can reduce the power of a marine surge up to 75% (Global Nature Fund, 2007).

Mangroves also prevent erosion by acting as buffers and catching alluvial materials, thereby stabilizing land elevation by sediment accretion that balances sediment loss. In addition, mangroves functionally act as natural water treatment systems by retaining heavy metals, trapping sediments, and providing chemical buffering and water quality maintenance of both rainfall and tidal inundation.

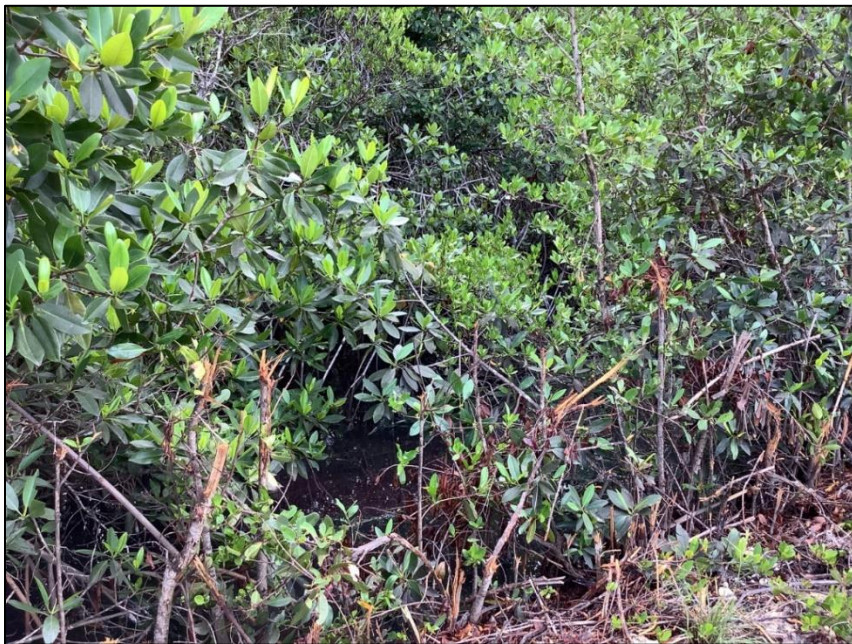
Figure 9: Central Mangrove Wetland (July 2023)

The CMW is part of a large-scale, water flow system which filters and conditions the surface water and shallow ground water that flows into the North Sound while providing a constant flow of nutrients, which form the base of a complex food chain for both terrestrial and marine wildlife (**Figure 9**). In addition, the CMW has an important role in the evapotranspiration/precipitation cycle of Grand Cayman, including rainfall generation. An estimated 40% of the rainfall in western districts of the island is believed to be due to evapotranspiration in the CMW (Bradley et al, 2004). The evaporation of water from mangrove swamps creates a seaward hydraulic gradient for the regional flow regime (Ng et al., 1992). The evaporative loss for Grand Cayman is estimated to be approximately 75% to 85% (Ng et al., 1992).

The hydrologic and drainage patterns of the CMW change throughout the year. During the wet season months of April through October, the CMW is typically fully inundated with overflows into the North Sound. During the dry season months of November to March, a draw-down of the water surface can occur unless heavy or sustained rainfall or sea water inundation is received. The Lower Valley Freshwater Lens and North Side Freshwater Lens feed into the CMW year-round.

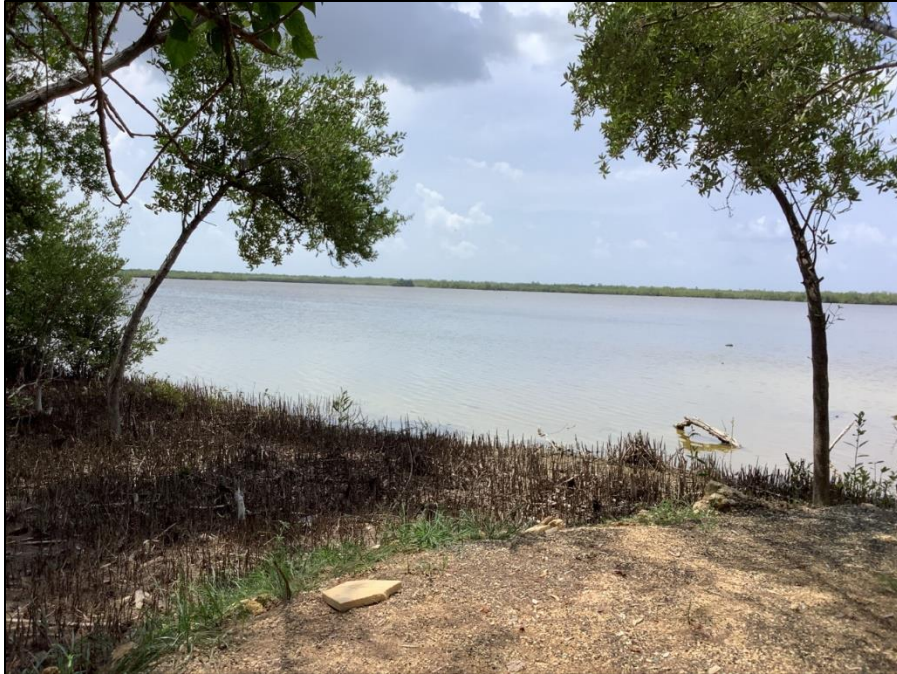
Figure 12: Meagre Bay Pond, facing North from access off Bodden Town Road (July 2023)

The Pond is situated on limestone of the Ironshore Formation, which creates a perched water table and has little or no connection to the underlying groundwater. Through the wide beach ridge, the Pond has a highly damped and attenuated connection to sea water. Therefore, the water level of the Pond fluctuates due to the seasonality of rainfall. From May to November, rainfall exceeds evapotranspiration and so the Pond water elevation is higher. In the most arid months of March and April, Pond water levels are at their minimum and water salinity is at its maximum. Sea spray generated by waves breaking on the fringing reef and carried in by southerly winds deposits salt into the Pond year-round. Salt is flushed out of the Pond when prolonged and heavy rains result in surface sheet flow across the CMW to the North Sound.

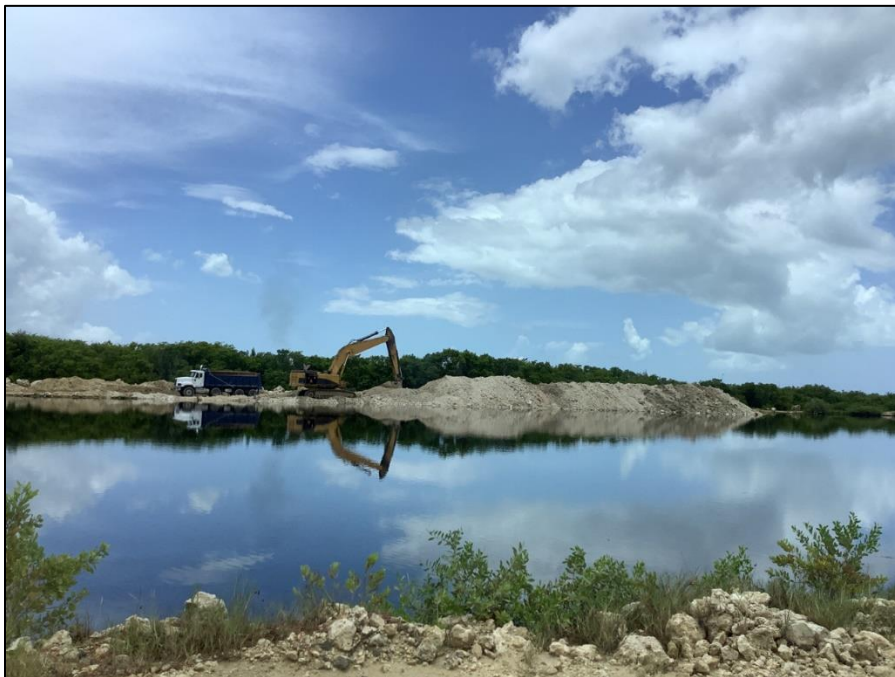
Figure 13: Active Quarry located northeast of Meagre Bay Pond (July 2023)

The adjacent quarries have also impacted the hydrology of the Pond. The quarry to the west of the Pond is not active, but the quarry to the northeast of the Pond is still active. By 2004, the quarry

west of the Pond had been excavated below the Pond water level, and in 2008, the expansion of this extended into the 300-ft (91 m) buffer zone of the Pond. The quarry water mixes with brackish groundwater and sea water influenced by marine tides. The interconnection of the quarry water threatens the salinity of the Pond when high tides spill large volumes of brackish quarry water into the Pond. This occurs whenever the water level in the quarry exceeds the elevation of the quarry rim road. This condition potentially inhibits the seasonal dry-down of the Pond and, with repeated inputs of brackish water, may increase salinity during the dry season. In addition, the quarry development around the Pond could disconnect the Pond from the CMW, which could limit the periodic salt flushing during heavy and prolonged rainfall events. Pollutants in the closed, flooded quarry, such as lubricating oil and hydraulic fluid from quarry machinery, can enter the protected area when the water level is high. Non-native tilapia cichlid fish from the closed quarry have also migrated to the Pond, which may adversely impact the Pond’s native biodiversity.

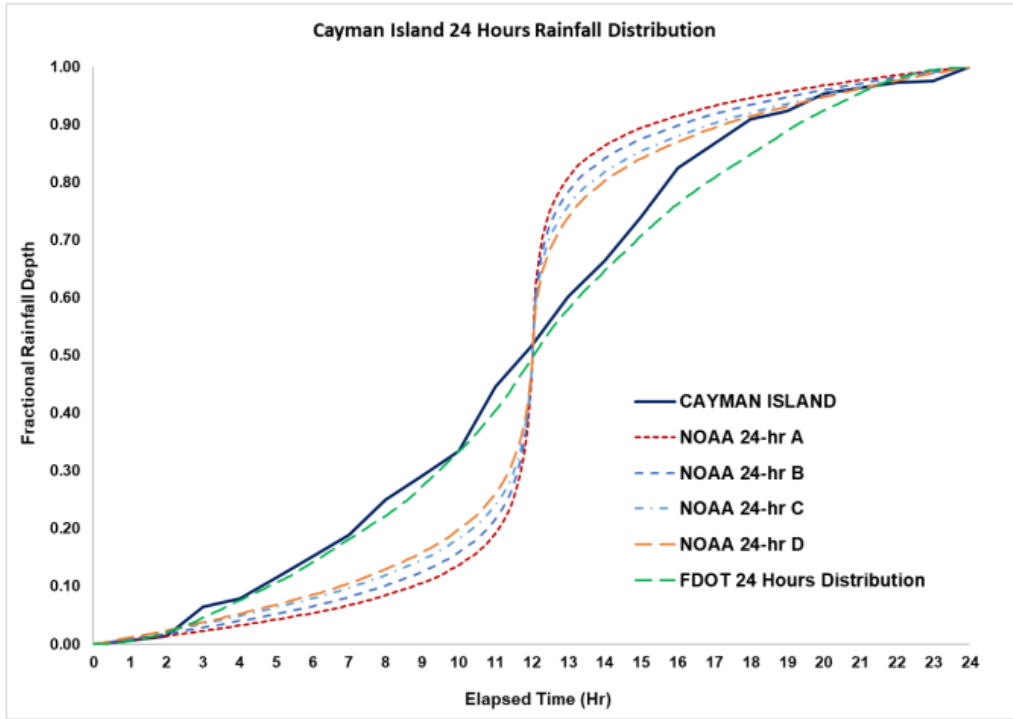
Figure 15: Grand Cayman Rainfall Distribution

Daily (24-hour) rainfall data collected by sixteen WAC rain gauges between 1982 and 2021 was used to determine the maximum daily (average 24-hour) rainfall intensity and identify extreme events. Hourly data from four weather stations was used to create events for the rainfall distribution analysis (**Figure 15**) to develop Intensity-Duration-Frequency (IDF) curves (**Figure 16**). The associated rainfall intensities and return periods were calculated for the generated time series durations, including 5 minutes, 10 minutes, 15 minutes, 30 minutes, 1 hour, 6 hours, 12 hours, and 24 hours and used to develop the IDF curves.

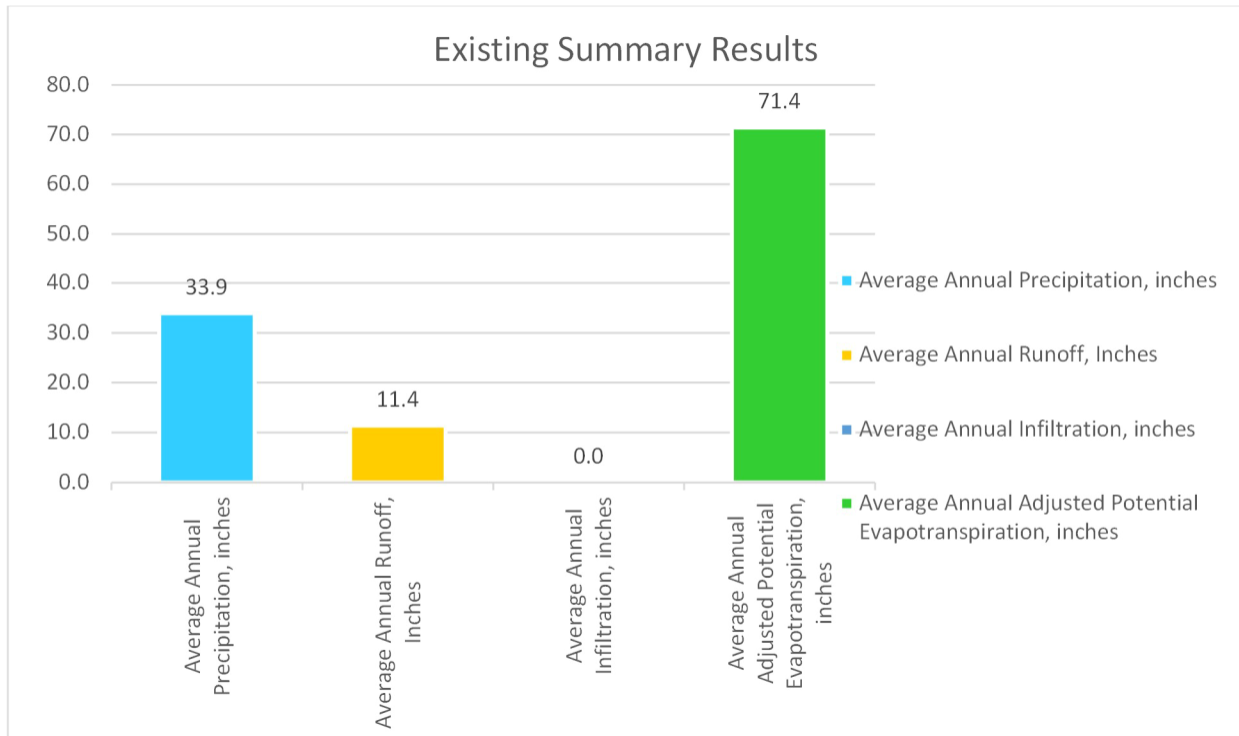
Figure 18: Existing Water Budget Summary Results

A water budget analysis was completed for the CMW for existing and proposed conditions. The results indicate that the CMW pool and water level would not be affected by the proposed Build alternatives. See **Figure 18** and **19** for the existing and proposed water budget respectively. These figures demonstrate the negligible effects of the Build alternatives on the water budget of the CMW.

Under existing conditions, the study notes that most rainfall within the CMW study drainage area is consumed by evapotranspiration. Of the 33.9 inches (86.1 cm) of average annual rainfall, 11.4 inches (28.9 cm) becomes runoff, 0 inches (0 cm) is infiltrated from the Lower Valley Lens into the CMW, and 71.4 inches (181.4 cm) is utilized by evapotranspiration in the study drainage area of the CMW.

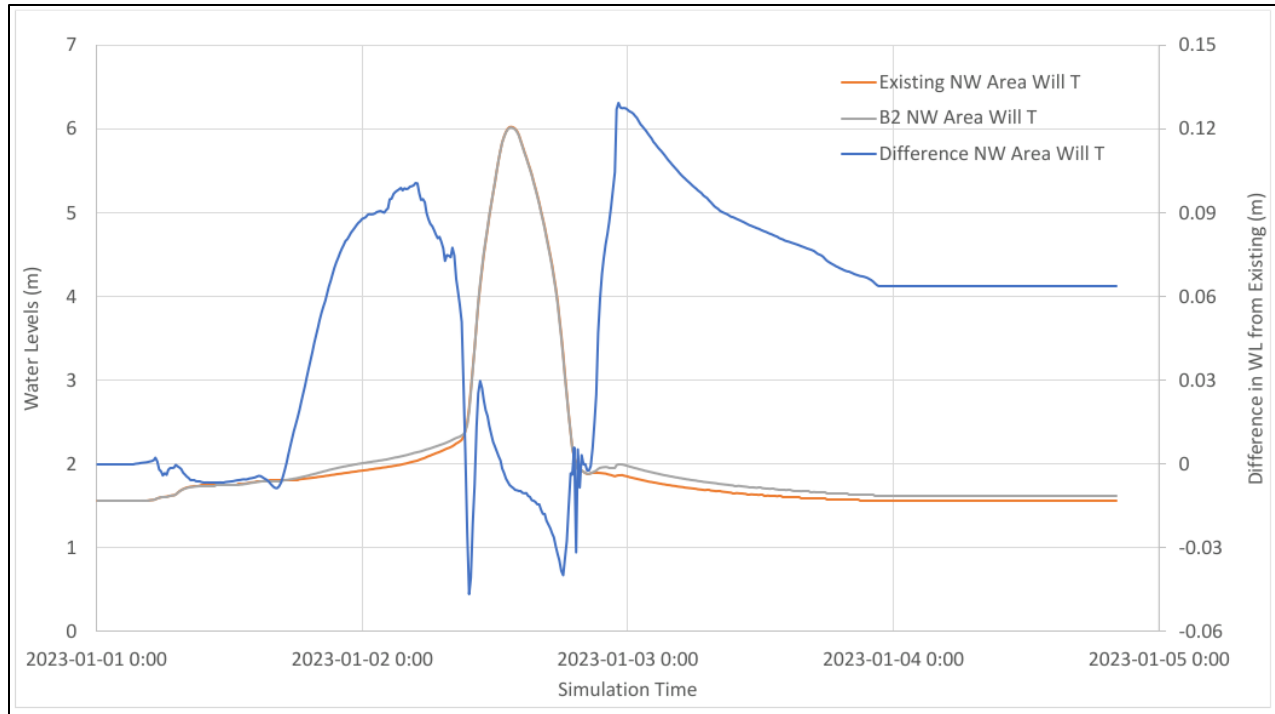
Figure 20: Example of Ponding Issue in Shallow Regions

Rainfall runoff and storm surge modelling was also completed to assess the potential drainage impact of the Build alternatives on the developed areas based on the same parameters as was used for Meagre Bay Pond above. Overall, the results showed a slight decrease in the peak water level for Build alternatives B1, B2, and B3. The study also showed that the water level in the developed areas exceeded the existing condition water level for a length of time for these alternatives. The results showed longer flood durations at NW Area, Will T and Rossini Drive, but these are attributed to slight local differences in shallow drainage, rather than any broad impoundment of water in the area for Alternatives B1 and B3. An example of this local shallow drainage effect for a specific location along the B2 Build alternative is shown in **Figure 20**.

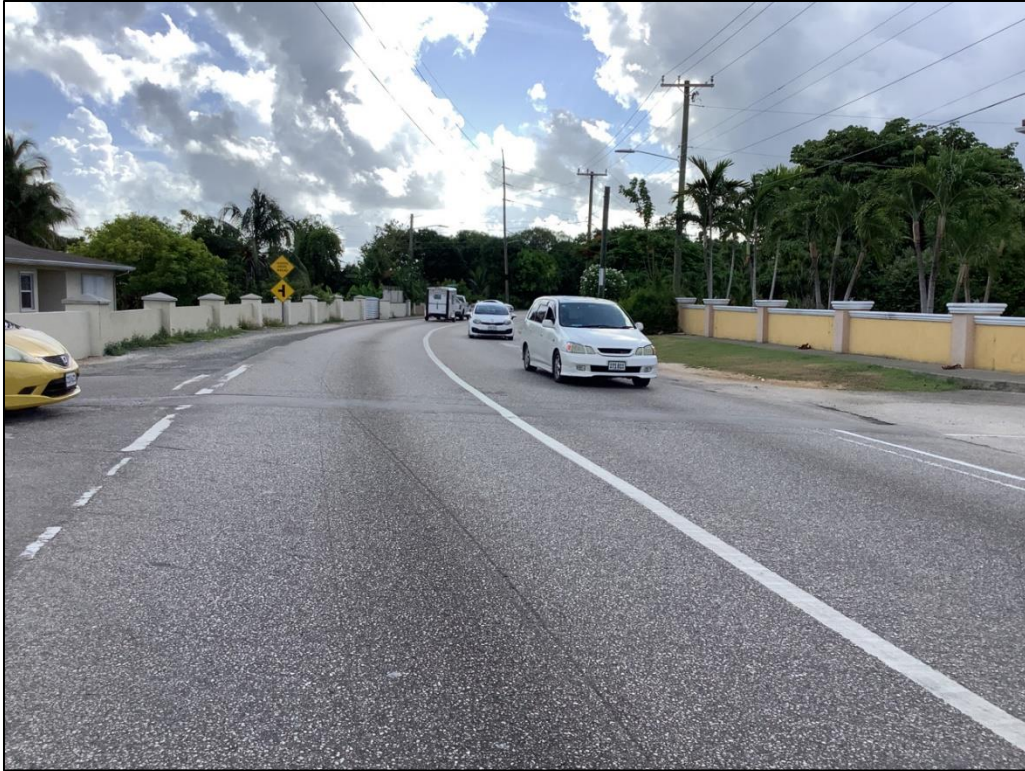
Photo 1: Two-lane road in residential area with relatively short decorative walls (July 2023)

During the field walk, several existing roadways were traversed including Lookout Road, Bodden Town Road, Shamrock Road, and Hirst Road. Pictures were taken to document the existing conditions of the roads. Generally, the existing roads were two lane roads with housing developments, businesses, and government buildings in close proximity to the road. There were some locations, particularly along Shamrock and Bodden Town Roads, with small (approximately 3 to 4 ft (0.9 to 1.2 m) tall) decorative walls that were only a few feet from the edge of the roadway on either side of the road (**Photo 1**). Bodden Town Road was at times close to the ocean (**Photo 2**). Bodden Town Road is also in close proximity to Meagre Bay Pond. The roads follow the existing topography with Hirst and Shamrock Roads rising along the ridge located in the Bodden Town Area and Bodden Town Road following the coastline. Bodden Town Road is located several feet above sea level for a majority of the EIA study area with only a few locations, particularly at Meagre Bay Pond, dropping closer to sea level.

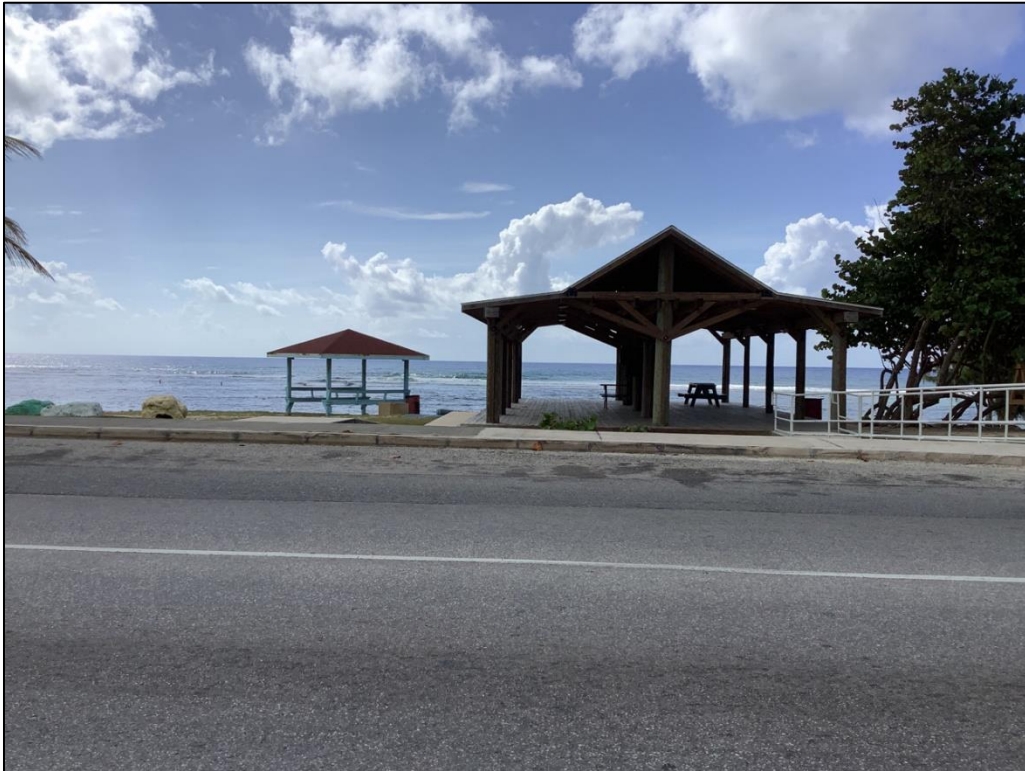
Photo 2: Bodden Town Road in close proximity to the ocean (July 2023)

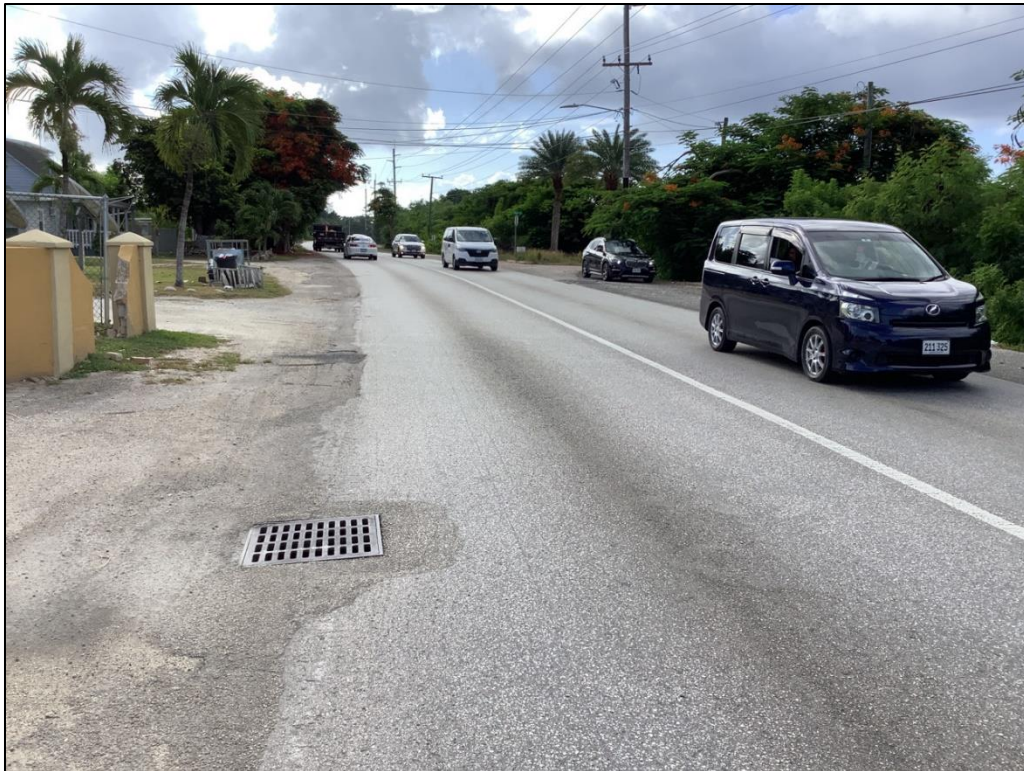
The existing inlets and drainage systems in the roadways were also observed during the field view. The observed drainage systems consisted of shallow inlets located on the roadside in between the edge of the roadway and the adjacent properties (**Photo 3**). Several locations contained multiple inlets that were connected with small pipes (approximately 15-inches in diameter, maximum) (**Photo 4**). There were also several locations of kerb and gutter that contained combination kerb opening/grate inlets with grates that indicated they were manufactured in the USA (**Photo 5**). All the inlets either drained to or contained a drainage well standpipe (**Photo 6**). Most of the well standpipes were observed to be approximately 8-inches in diameter and were fabricated from Polyvinyl Chloride (PVC) pipe. The ends of the PVC standpipes were generally oriented upward with no trash racks or other screening devices. Several of the wells observed contained perforations along the raised portion of the standpipe. Water was visible within most drainage/well standpipe inlets with a few of the standpipes appearing clogged with debris (**Photo 7**). Conversation with NRA field personnel in July 2023 verified that the water table is close to the surface in most locations and that the well standpipes are cleaned out periodically to ensure they will function properly during the hurricane season.

Photo 3: Typical inlet location (July 2023)

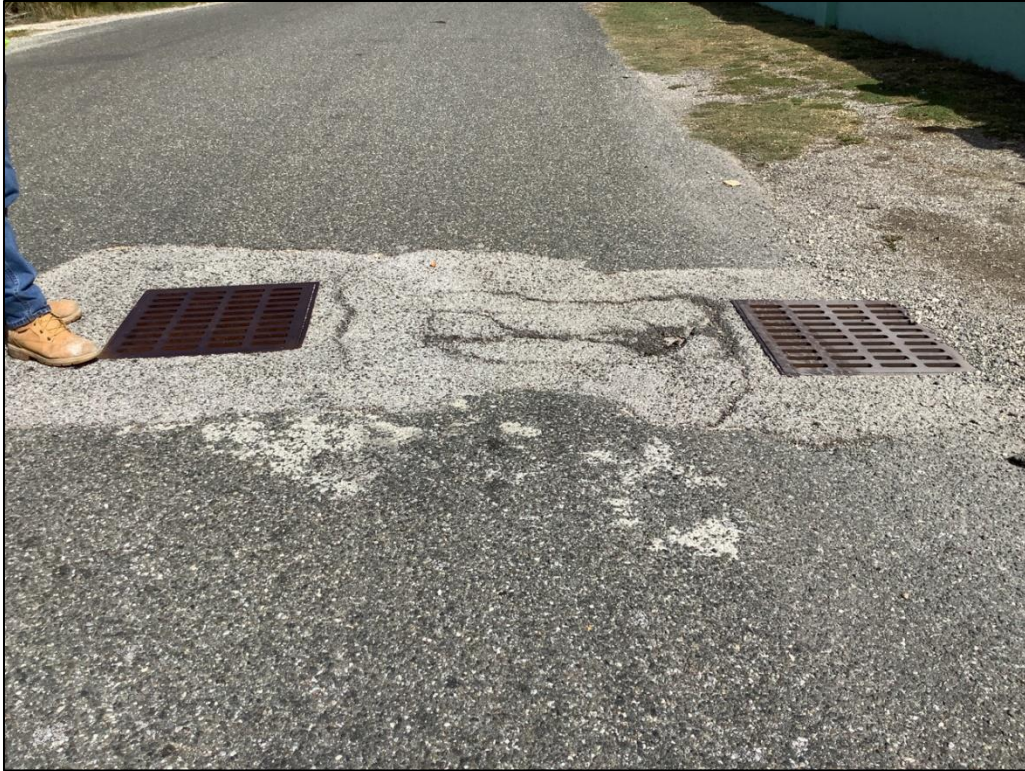
Photo 4: Inlet on shoulder drains to inlet in centre of roadway (July 2023)

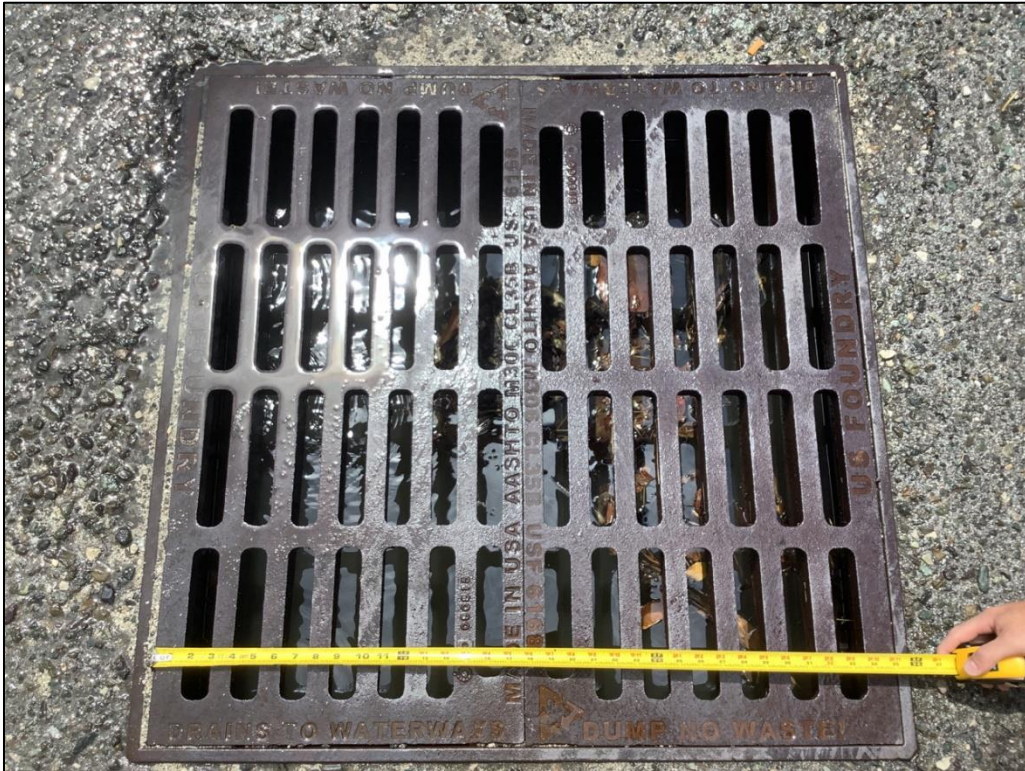
Photo 5: Made in USA inlet (July 2023)

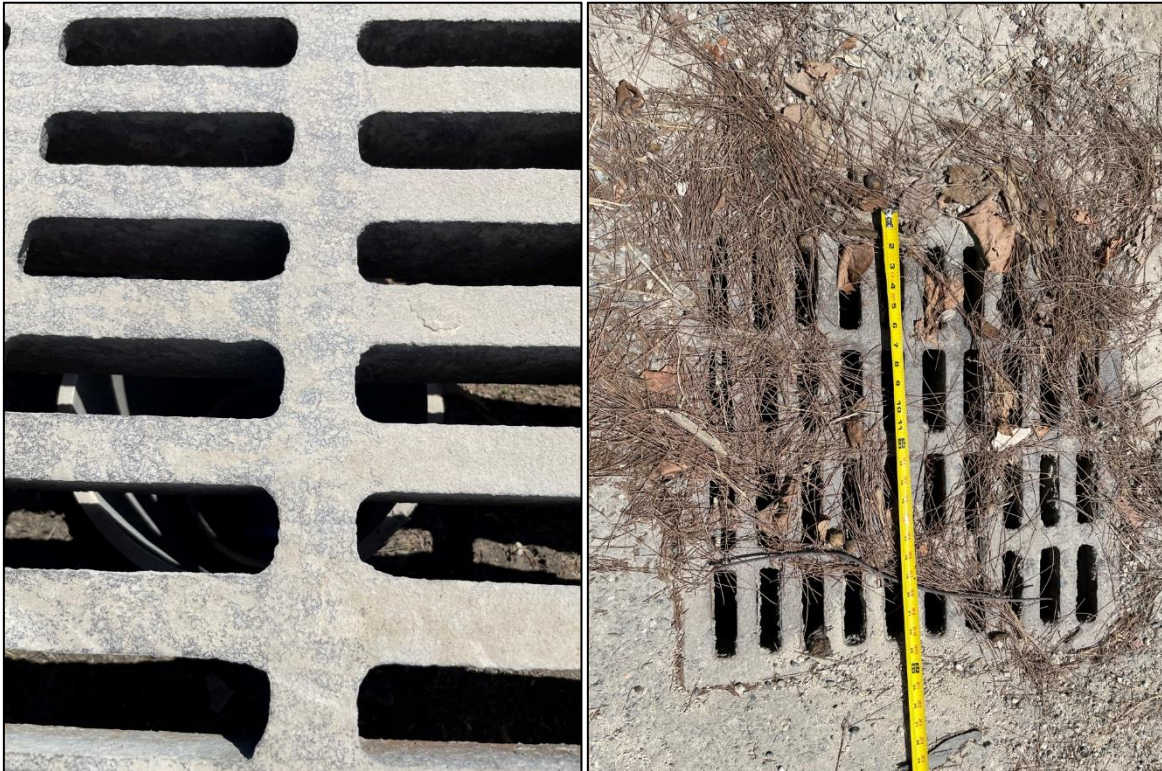
Photo 7: Inlet clogged with sediment (left) and debris (right) (July 2023)

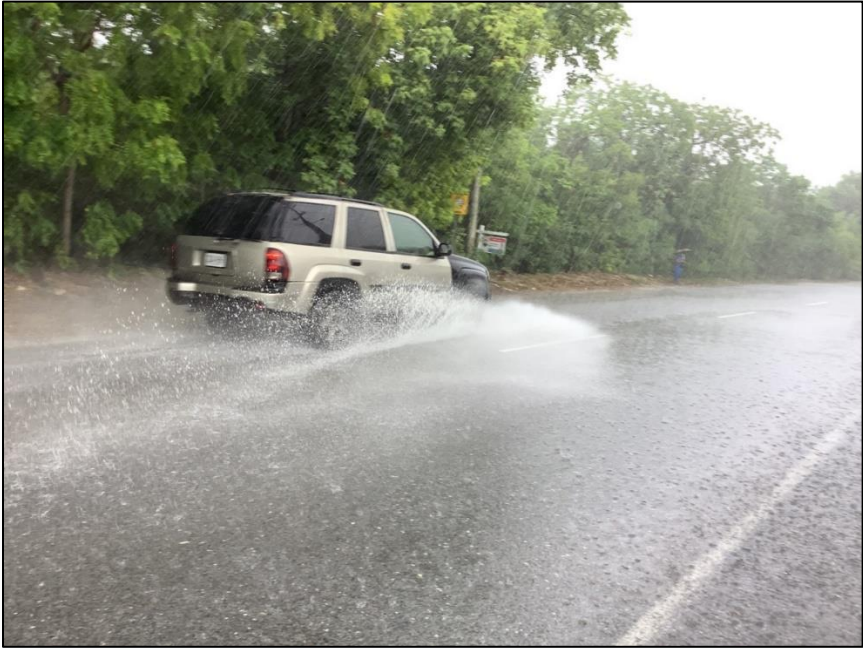
A rainfall event was observed during the field view. During the rainfall event, the water drained from the roadway to the roadside and ponded above the inlets. The water ponded on to the roadway surface in several locations with the worst of these locations having the water almost reach the centerline of the road (**Photos 8 and 9**). These locations were also observed approximately 1.5 hours after the rainfall stopped and the drainage wells in the inlets had drained runoff from the roadside.

Photo 8: Flooding on Boddan Town Road during rainfall event (July 2023)

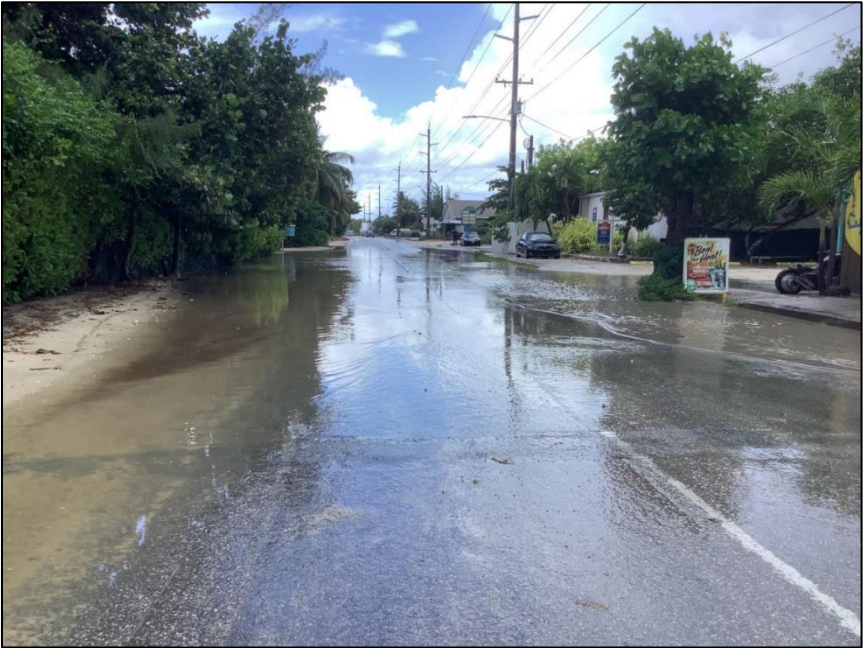
Photo 9: Flooding on Boddan Town Road after rainfall event (July 2023)

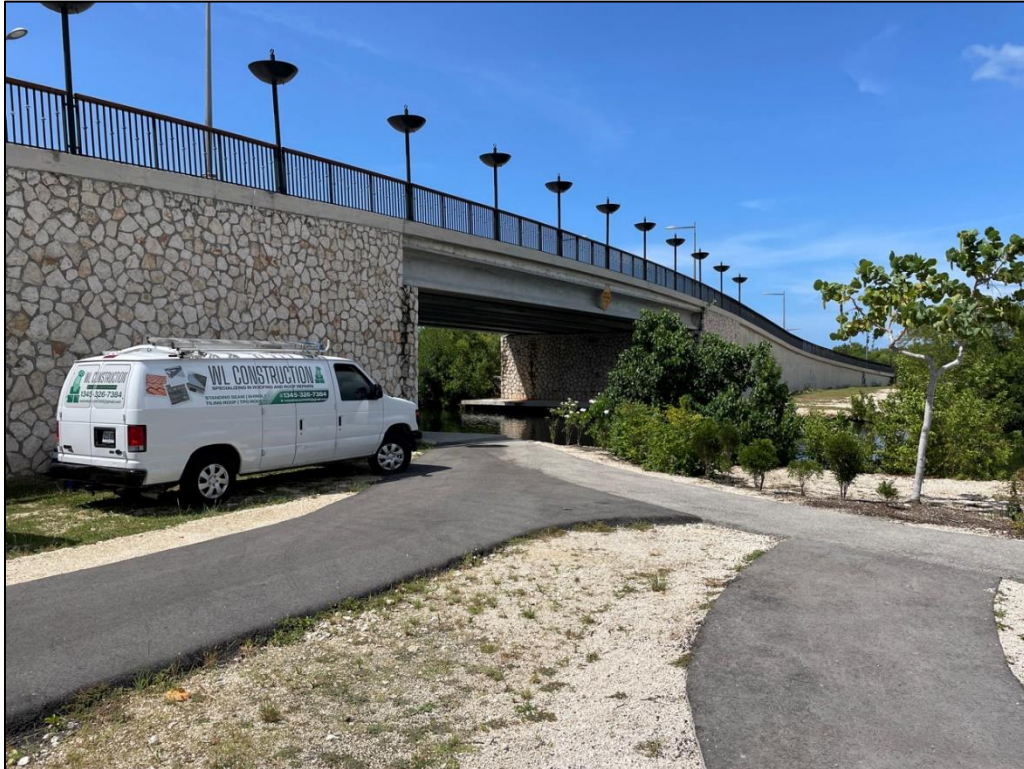
Research prior to the field review identified the location of only one existing bridge on Grand Cayman in the Seven Mile Beach area. Observations during the field review indicate that the bridge was raised with a 17-foot (5-meter) clearance under the bridge. The bridge appeared to be constructed of concrete girders with embankment and retaining walls used to raise roadway approaches to the elevation of the bridge deck (**Photo 10**). No areas of erosion or stream instability were noted on the watercourse spanned by the bridge.

Photo 10: Existing Bridge in the Seven Mile Beach area (July 2023)

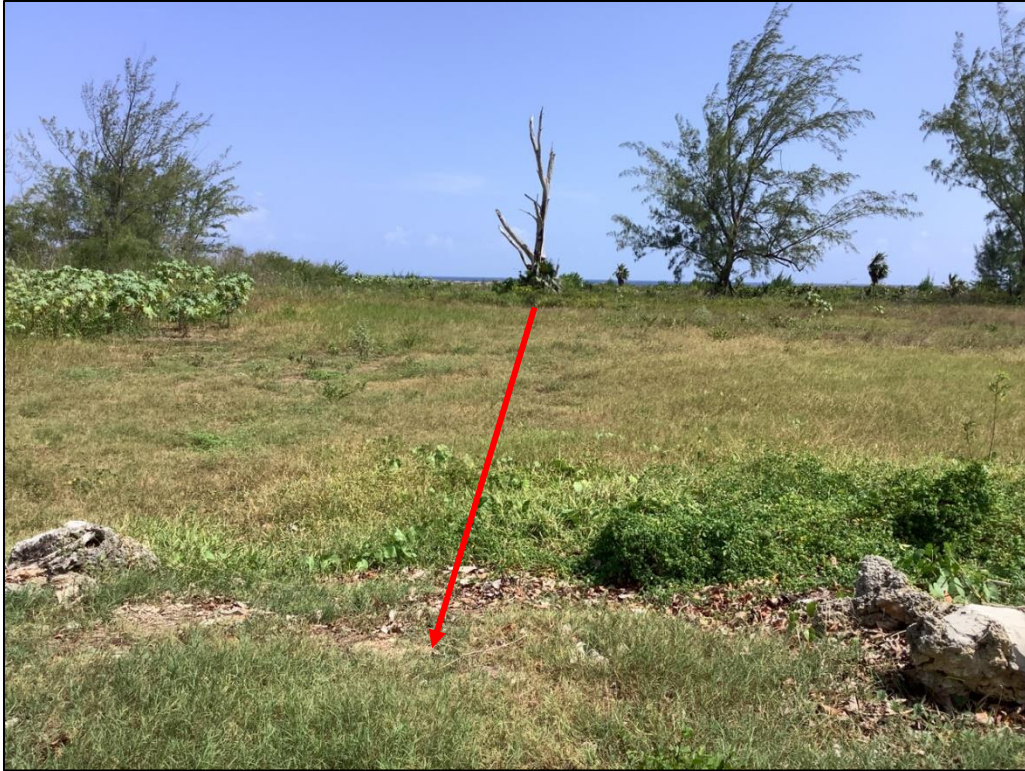
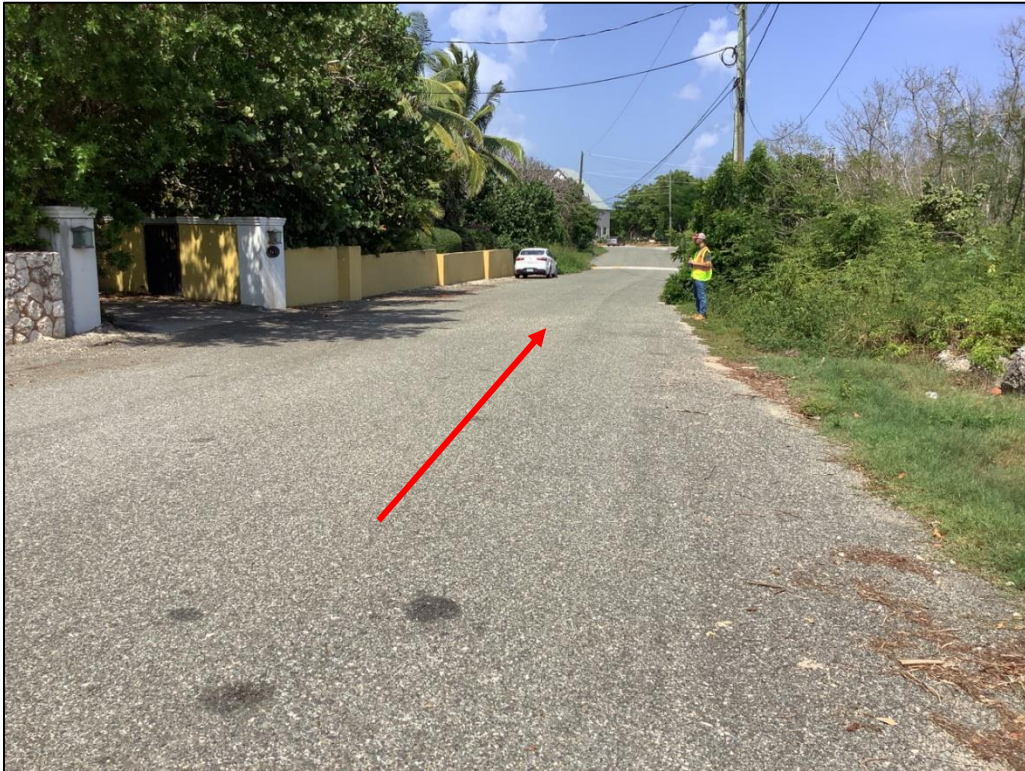
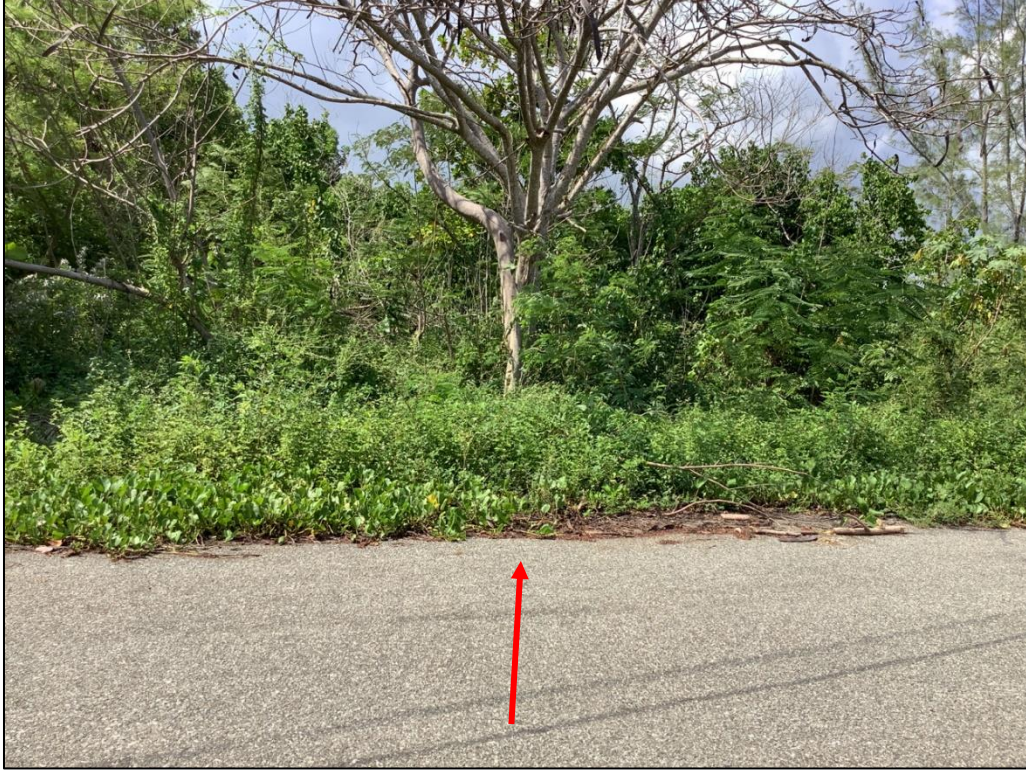
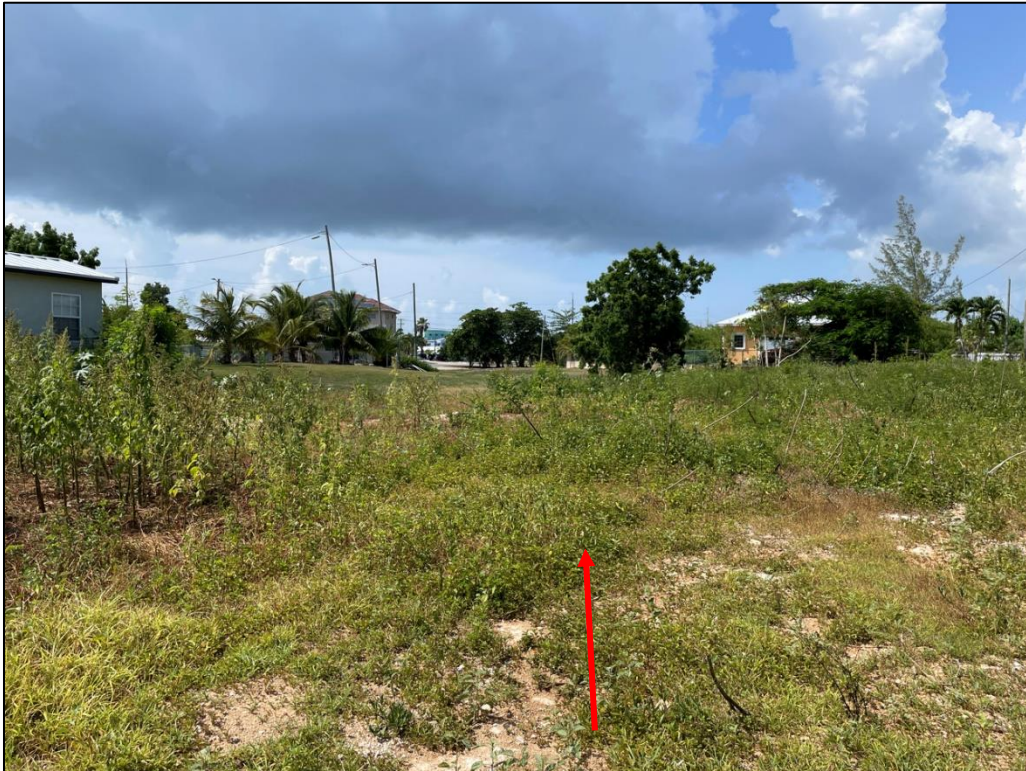
Photo 11: Savannah Gully, facing south from Sandy Ground Drive toward ocean (July 2023)

Photo 12: Savannah Gully, facing east along Sandy Ground Drive (July 2023)

Photo 13: Savannah Gully, facing north from Sandy Ground Drive (July 2023)

Photo 14: Savannah Gully, facing west from Sandy Ground Dr. Downslope extent (July 2023)

The Savannah Gully is an area of geographic relief along the south shore of Grand Cayman in the Savannah area that has been documented as a historical area of storm surge inundation and conveyance. In 2006, the Savannah Gully was flooded and a wall was designed to prevent subsequent surges from being conveyed over the gully and to the north; however, the wall was not constructed. The Savannah Gully has not been reported to have flooded since the 2006 storm event. Several photos were taken along Sandy Ground Drive in the vicinity of the gully to document the existing conditions. The relief area is easily observable along the shoreline and appears to run back along Sandy Ground Drive into the vicinity of Shamrock Road. There was an obvious increase in dense vegetation in the vicinity of the gully as well as an accumulation of plant and trash debris. **Photos 11 to 14** show the general direction of flow with red arrows.

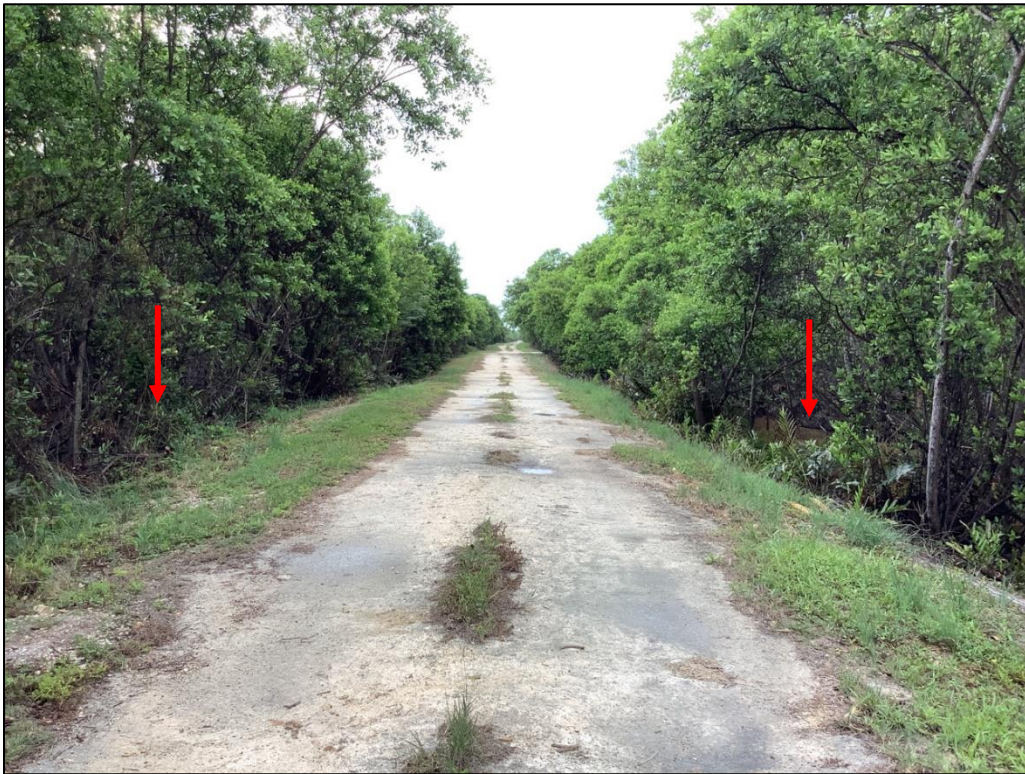
Photo 15: Access road with adjacent mosquito ditches (July 2023)

The Central Mangrove Wetland is densely vegetated and was only accessible during the field review via the roads along the archaic mosquito canals, or ditches, on the west side of the wetland located off the Windward Road near Nadine Street, just south of the North Sound (**Photo 15**). The ditches along the side of the road contained two observable reinforced concrete pipes (RCP) connecting the ditches underneath the roadway; however, there did not appear to be any flow in the ditches (**Photo 16**). The RCP were round with a 42-inch (1.1 m) diameter and a 2-inch (5.1 cm) wall thickness. At the western RCP, the observed water depth was 2.5-feet (0.8 m) from the pipe crown and 1.5-feet (0.5 m) from the ditch bottom. At the eastern RCP, water depth was 2.75-feet (0.84 m) from the pipe crown and 1.75-feet (0.53 m) from the ditch bottom.

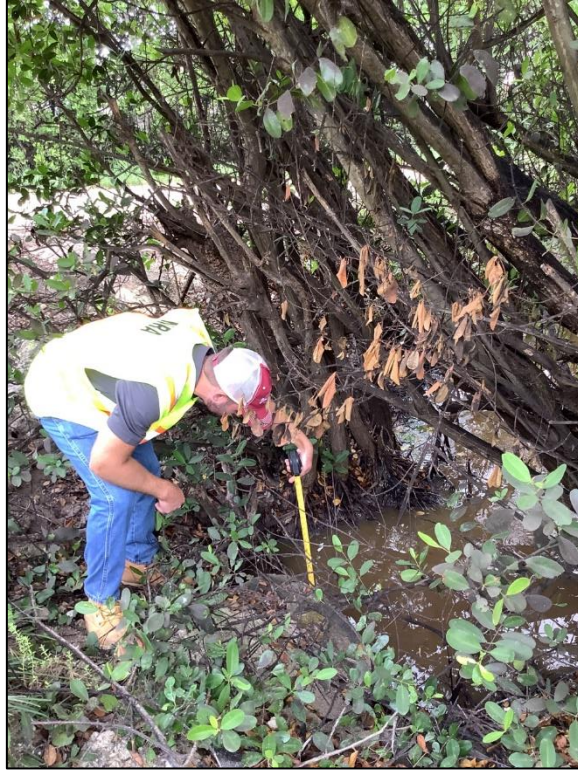
Photo 16: RCP drainage pipe (July 2023)

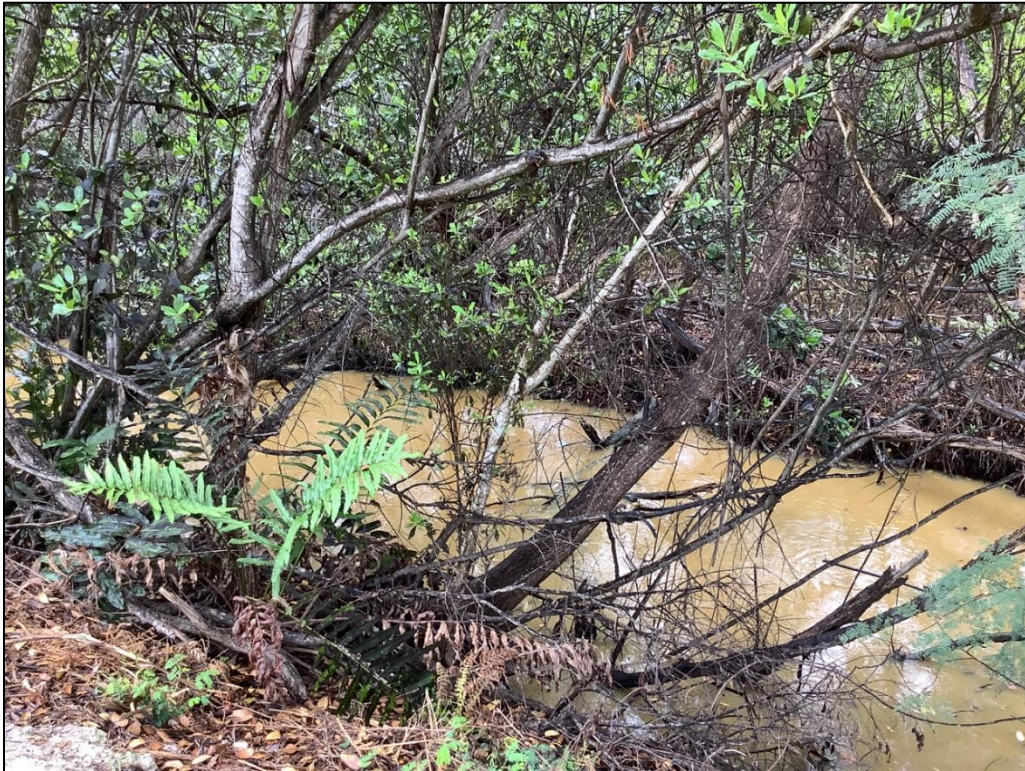
The ditches were, on average, approximately 10 feet to 15 feet (3 to 4.6 m) wide with 1.5 to 2 feet (0.5 to 0.6 m) water depth (**Photo 17**). The density and species of mangrove trees appeared to vary with proximity to the centre of the wetland. The amount of water inundating the wetland also appeared to increase towards the centre of the wetland with obvious signs of water level fluctuation visible on the vegetation. There were also multiple locations of exposed rock surface located throughout the wetland (**Photo 18**).

Photo 17: Drainage Canal (July 2023)

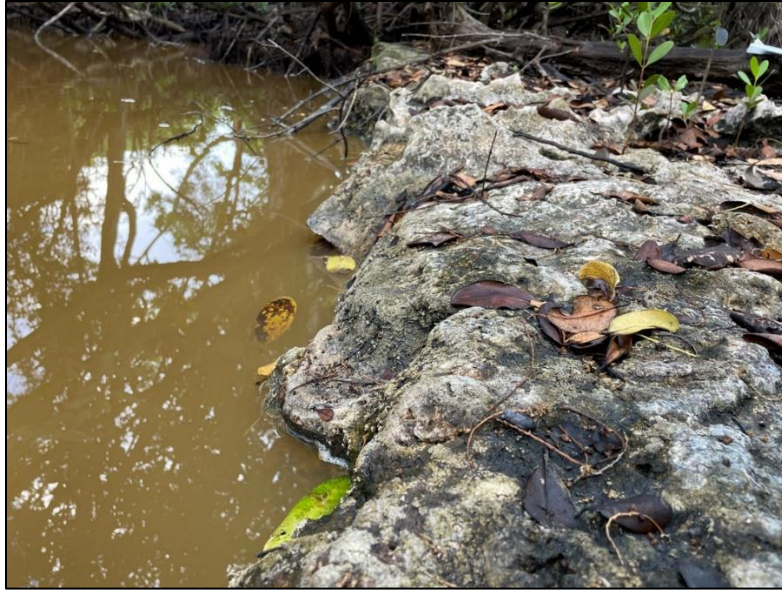
Photo 18: Bedrock outcrop in the Central Mangrove Wetland (July 2023)

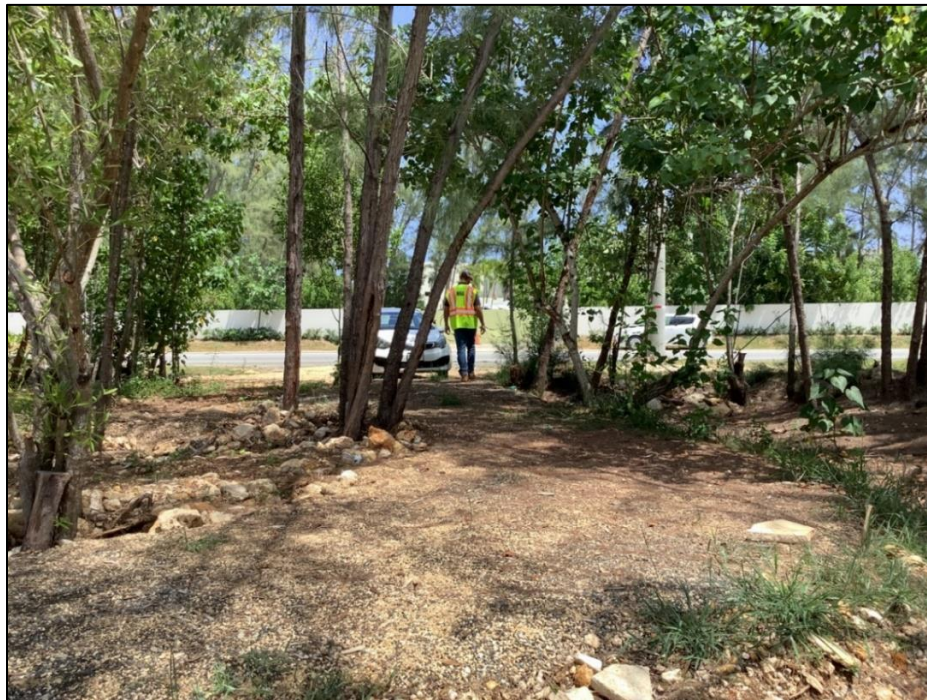
Photo 19: Access Trail to Meagre Bay Pond from Bodden Town Road (July 2023)

Meagre Bay Pond was accessed by a short trail off Bodden Town Road (**Photo 19**). The distance between the edge of the pond water and the edge of the roadway stripe was roughly measured to be 90 feet (27 meters). Quarry equipment was observed on the far side of the pond. The pond bottom as viewed from the bank consists mainly of sand with scattered rock outcrops and woody debris (**Photos 20 to 22**).
