Appendix E, Attachment H – Hydrology & Drainage – Assessment of Alternatives

East-West Arterial Extension:

Hydrology and Drainage FINAL

Assessment of Alternatives Grand Cayman East-West Arterial Extension

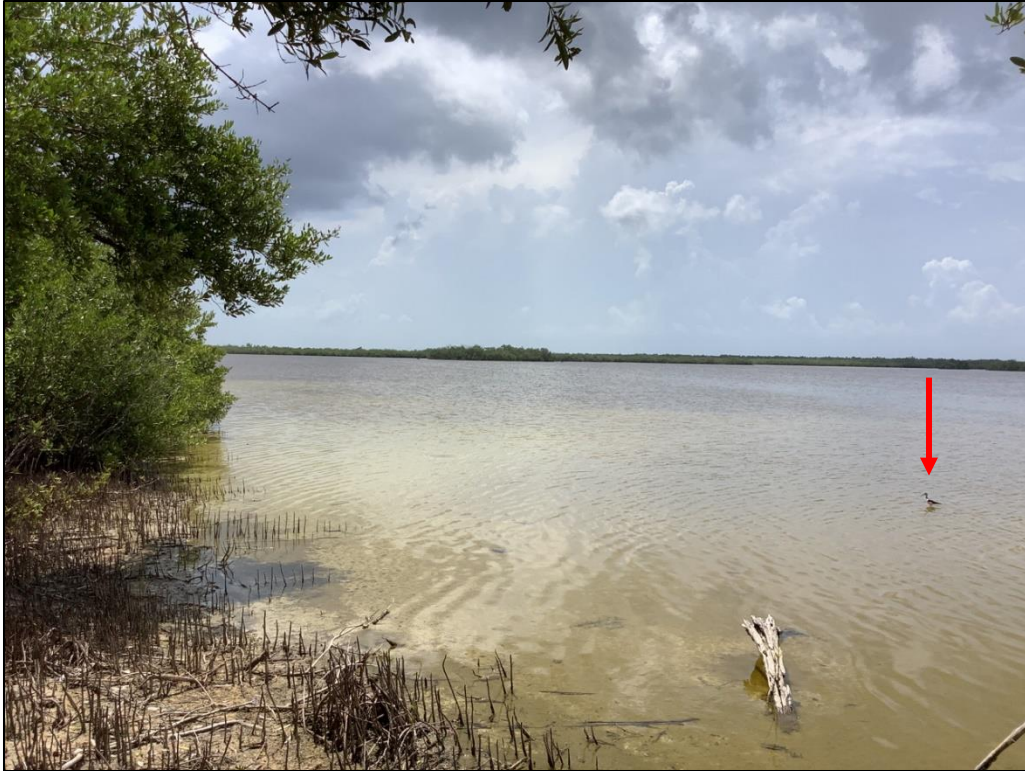
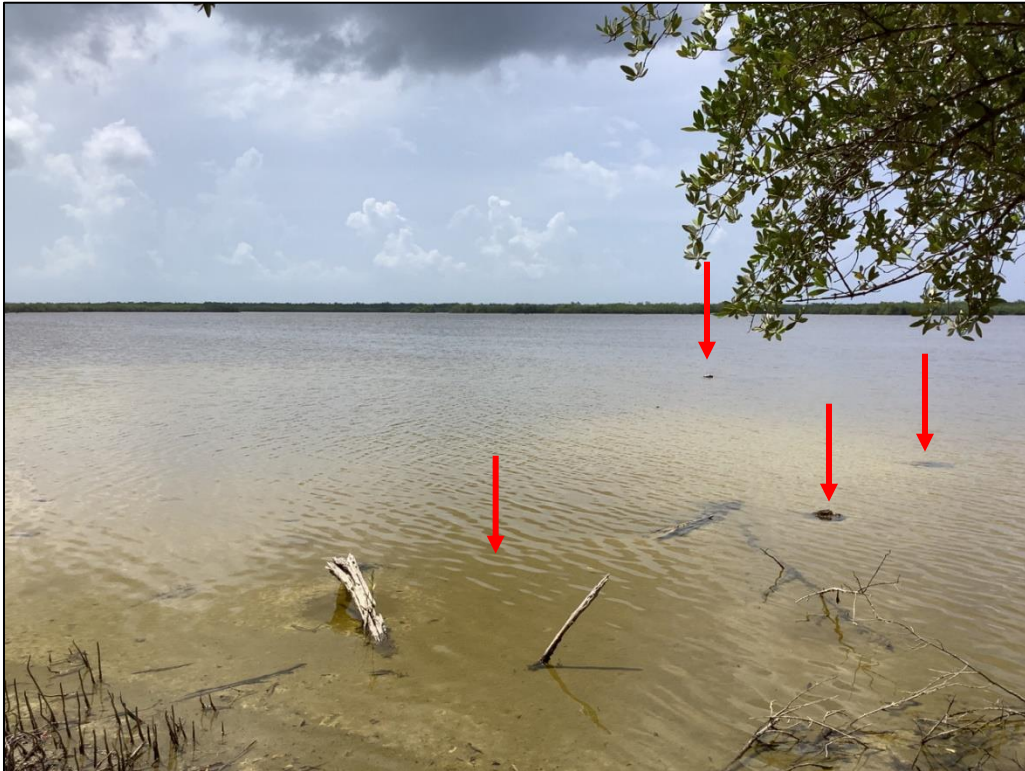
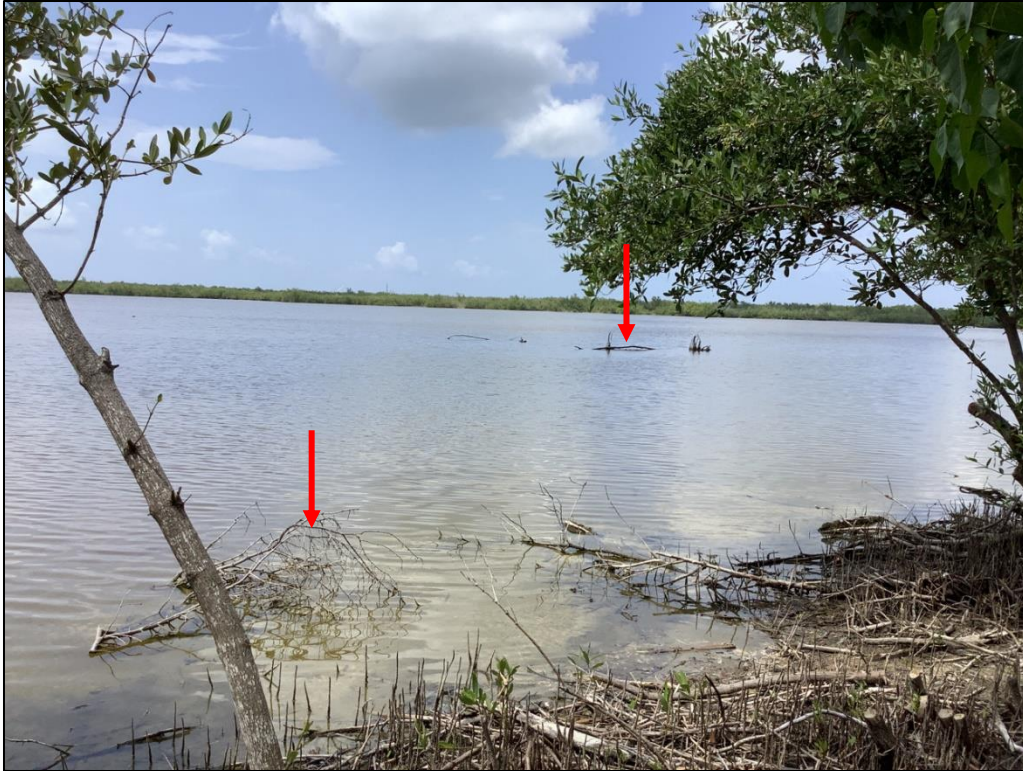
Photo 20: Meagre Bay Pond, facing Northwest. Bird in water. (July 2023)

Photo 21: Meagre Bay Pond, facing North. Sandy substrate and rock outcrops (July 2023)

Photo 22: Meagre Bay Pond, facing Northeast. Woody debris (July 2023)

Meagre Bay Pond was accessed by a short trail off Bodden Town Road (**Photo 19**). The distance between the edge of the pond water and the edge of the roadway stripe was roughly measured to be 90 feet (27 meters). Quarry equipment was observed on the far side of the pond. The pond bottom as viewed from the bank consists mainly of sand with scattered rock outcrops and woody debris (**Photos 20 to 22**).

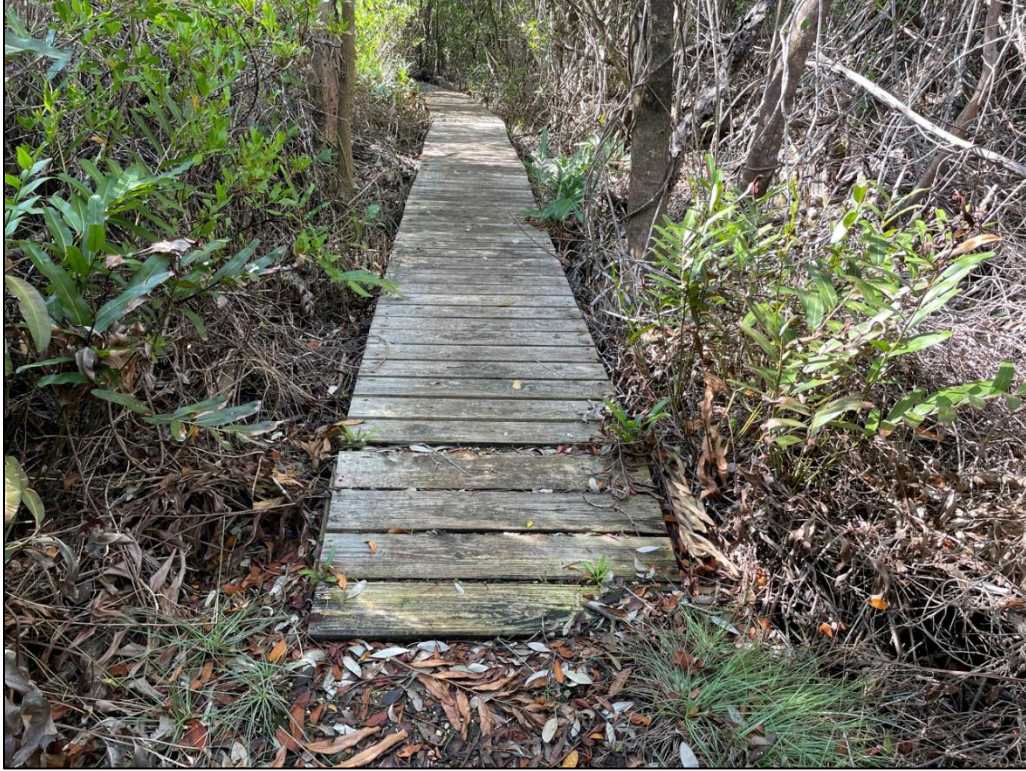
The two elevated boardwalks and the trail in vicinity of the Alternative B1 were measured. The southern boardwalk was 3 feet (0.9 m) wide, consisted of 2 inches by 6 inches (5 cm by 15 cm) wooden planks and was elevated up to 2 feet (0.6 m) above existing grade (**Photo 23**). The depth of existing standing water adjacent to the bridge was approximately 1.5 feet (0.5 m) in the deepest spot (**Photo 24**). The northern boardwalk was 4-feet wide, consisted of 2 inches by 6 inches (5 cm by 15 cm) wooden planks, and was elevated up to 29 inches (74 centimetres) above existing grade by PVC pipe posts (**Photo 25**). There was no standing water under or adjacent to the bridge. It appears that the existing bridge had replaced an earlier bridge. The trail in the vicinity of Alternative B1 was approximately 5 feet wide and had bedrock outcroppings (**Photo 26**).

Photo 23: Southern Boardwalk (July 2023)

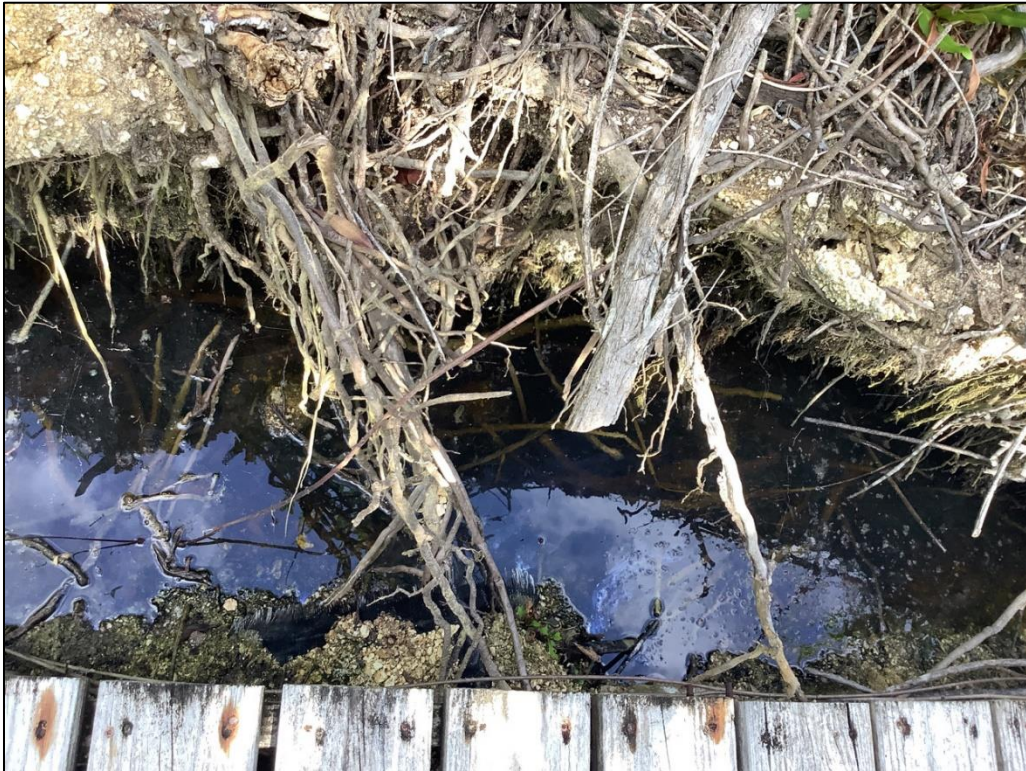
Photo 24: Standing water adjacent to southern boardwalk. (July 2023)

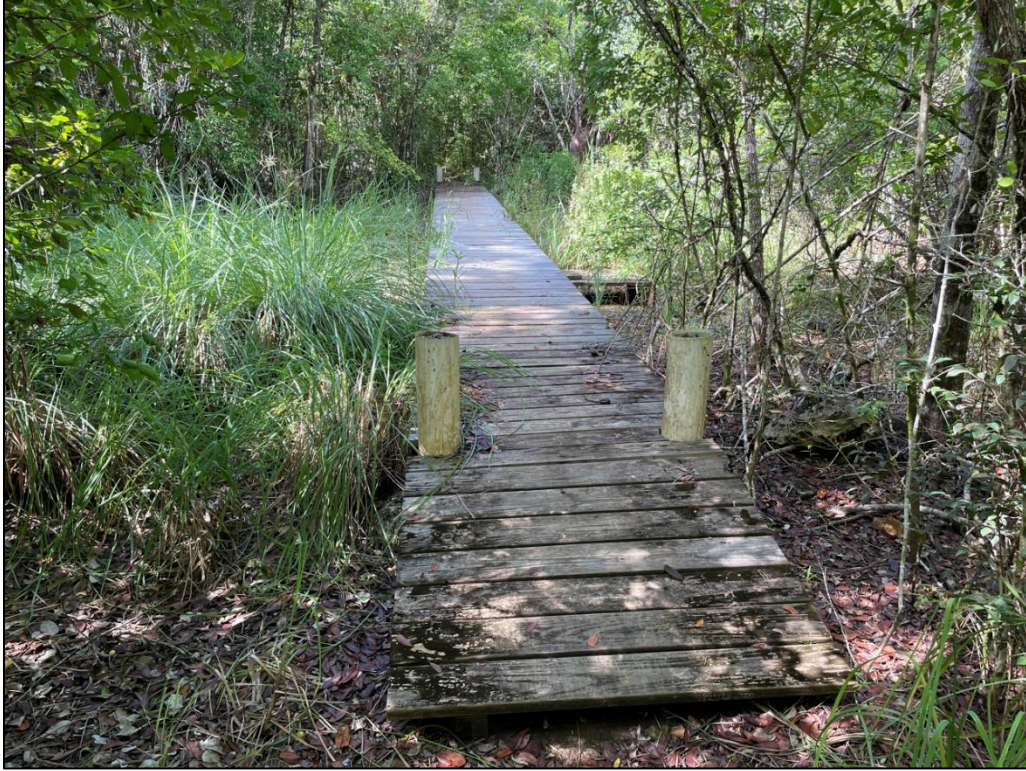
Photo 25: Northern Boardwalk, no standing water (July 2023)

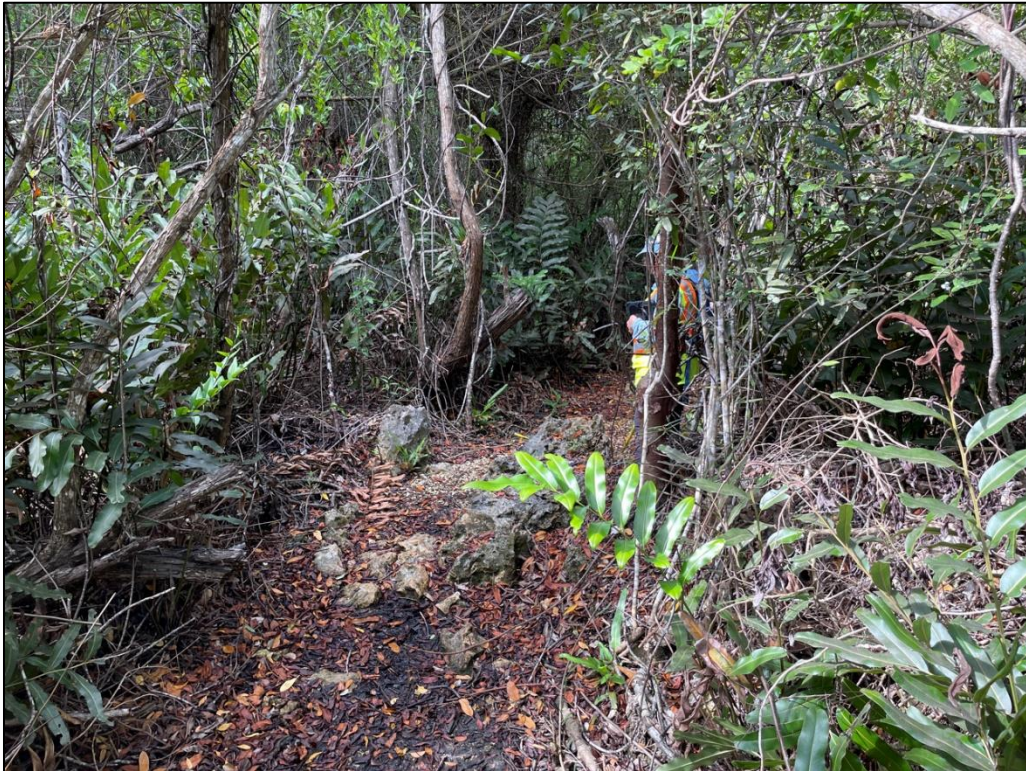
Photo 26: Trail in the vicinity of the Alternative B1 crossing. (July 2023)

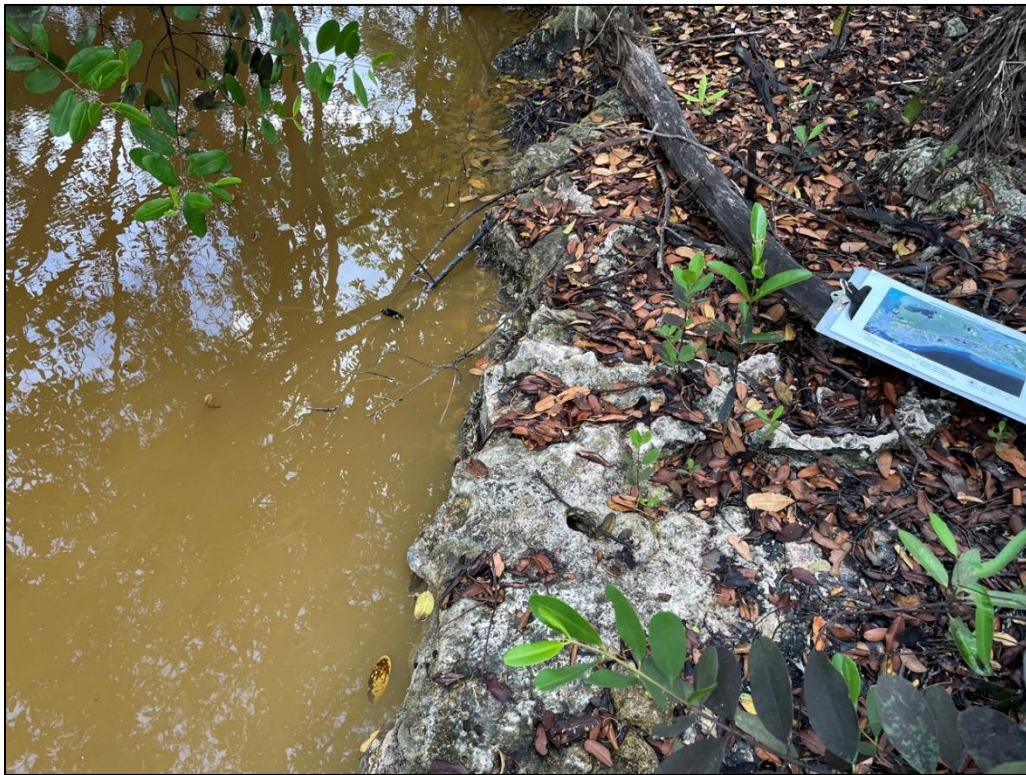
Photo 27: Bedrock outcrop in the Central Mangrove Wetland area (July 2023)

Exposed bedrock formations and peat were assessed during the field effort. Bedrock formations were found in the Central Mangrove Wetland area (**Photo 27**), near the existing EWA (**Photo 28**), Savannah Gully, Alternative B4, and Mastic Trail (**Photos 29 to 32**). Access was provided by the NRA to the quarry just east of the Meagre Bay Pond. Observations were made around the perimeter of the quarry up to the northern most point of the quarry where it borders the Central Mangrove Wetland. The quarry contained large excavators that were actively being used for excavation in the quarries (**Photo 33**). The NRA personnel also indicated that blasting was being used in the excavation process. Limestone is being excavated from the quarry (**Photo 34**). The excavation areas were filled with groundwater almost up to the existing ground level. The NRA personnel mentioned that the quarries are approaching 60-feet (18.3 m) in depth. Excess material was observed piled up around the perimeter of the quarry including piles of an unknown dark material on the north end of the quarry. The portion of the Central Mangrove Wetland that could be observed from the north end of the quarry was mostly covered with pools of water at the surface level and was populated with mangrove trees, similar to the portion of the wetland along the mosquito ditches. Peat was found in conjunction with the mangroves (**Photo 35**).

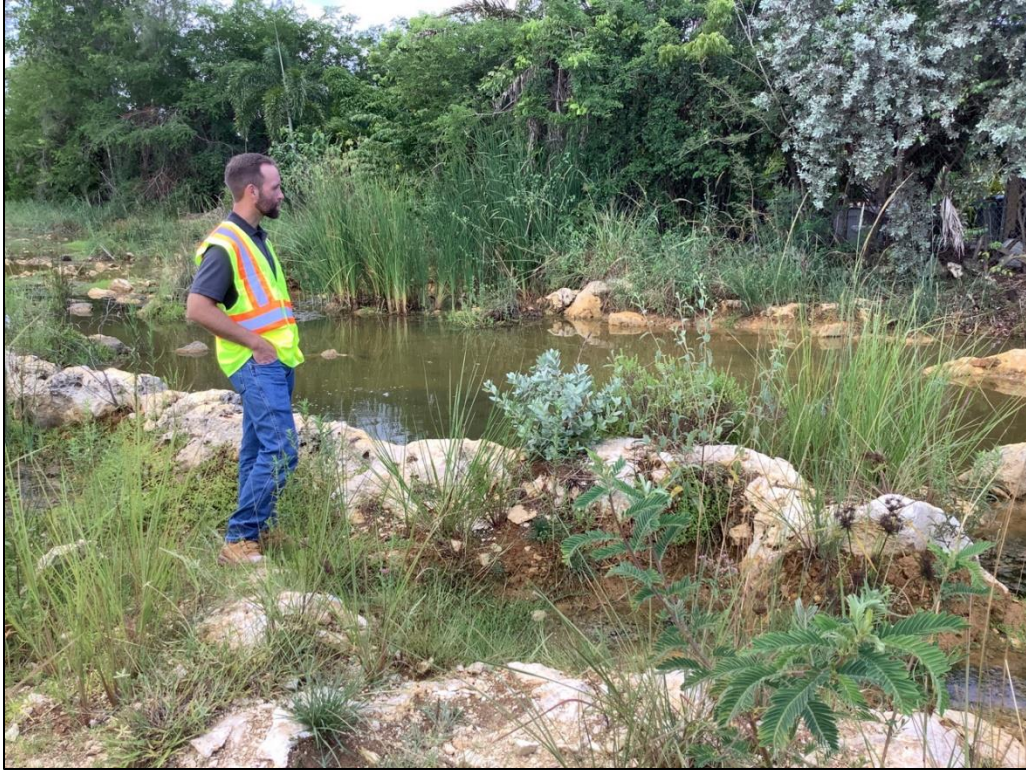
Photo 28: Bedrock outcrop near the existing EWA (July 2023)

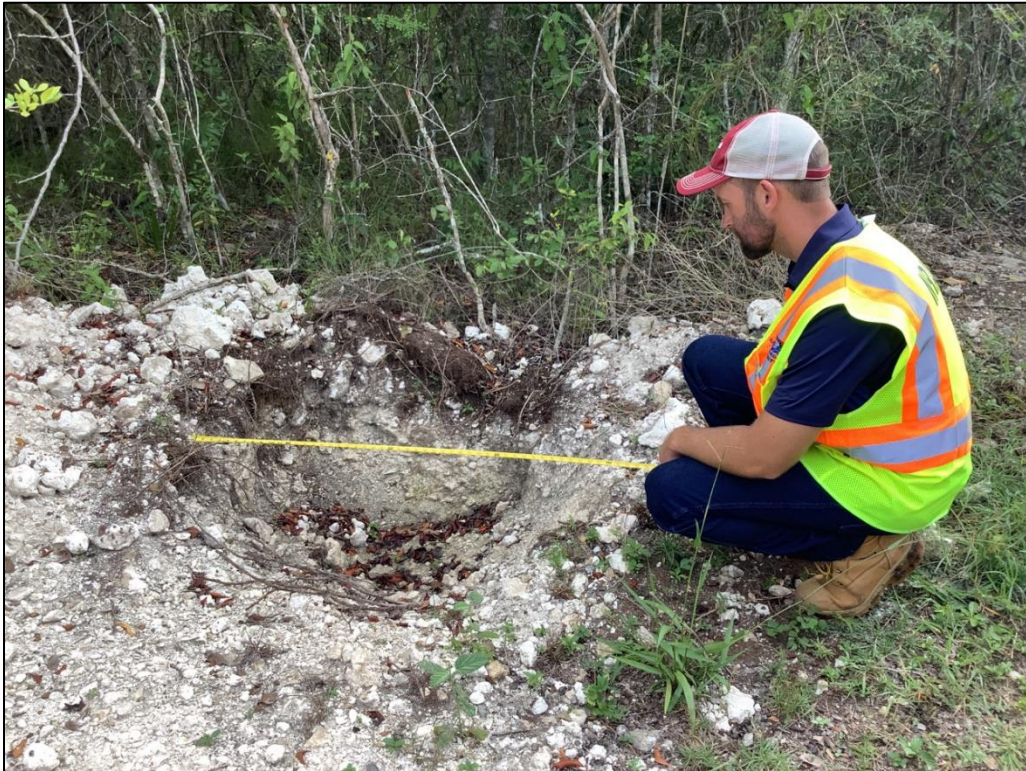
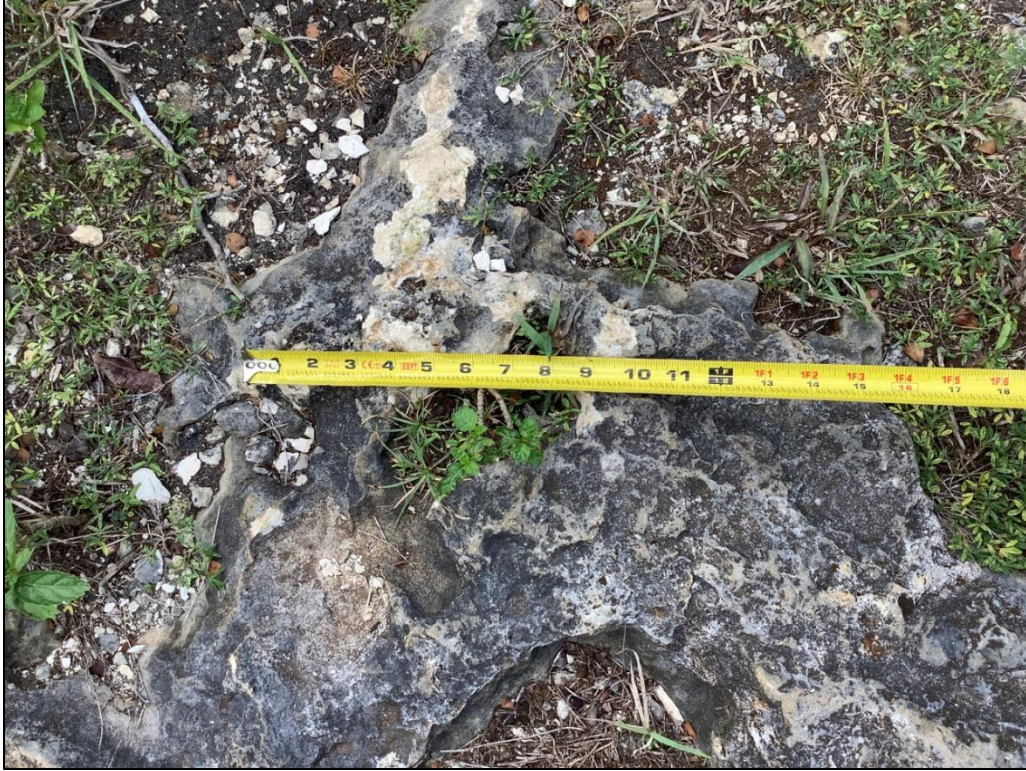
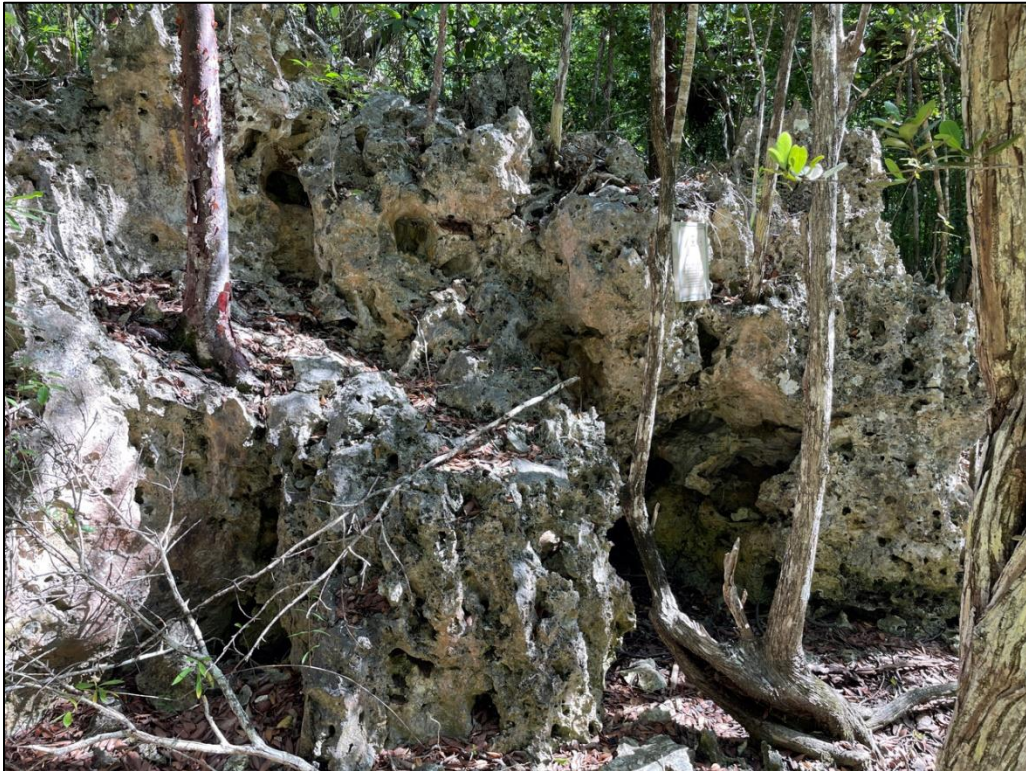
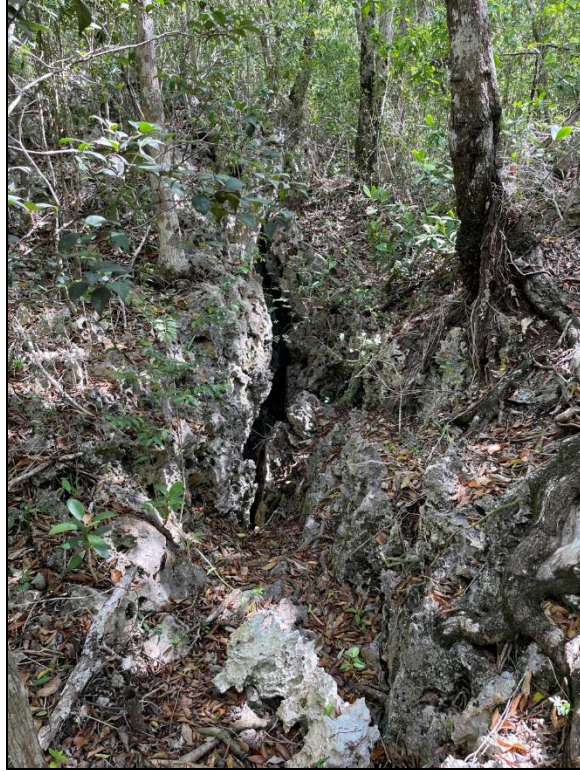
Photo 29: Limestone Pit along the Mastic Trail (July 2023)

Photo 30: Exposed bedrock along Mastic Trail (July 2023)

Photo 31: Large bedrock outcrop along the Mastic Trail (July 2023)

Photo 32: Crevice in the bedrock along the Mastic Trail (July 2023)

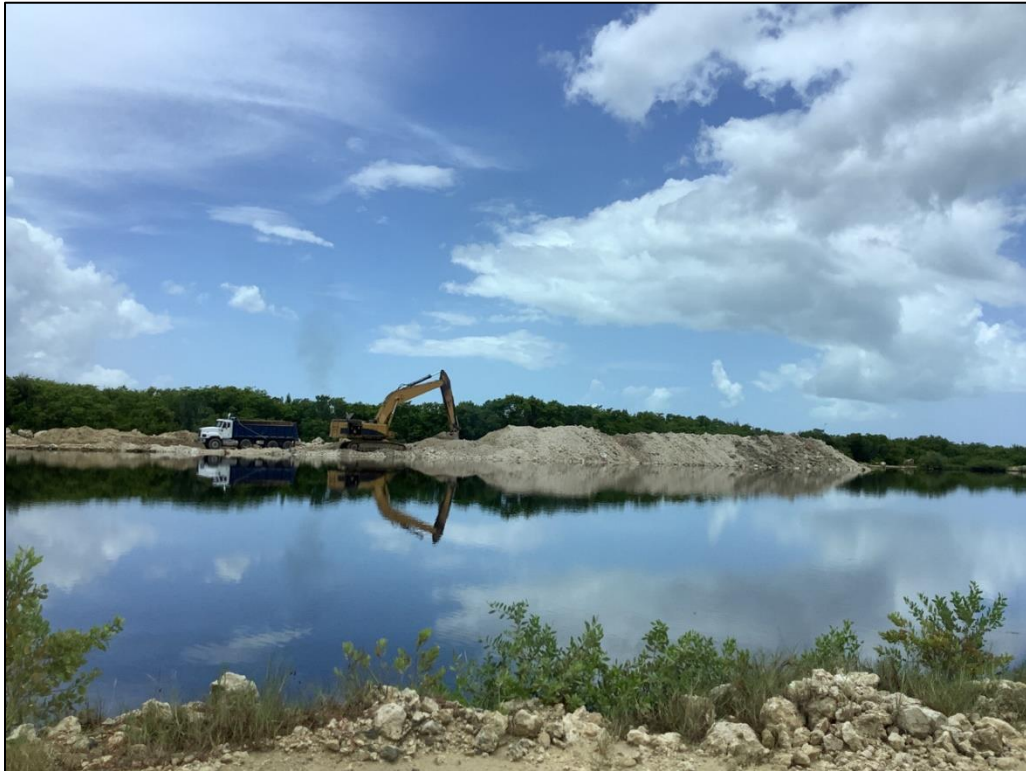
Photo 33: Active Quarry (July 2023)

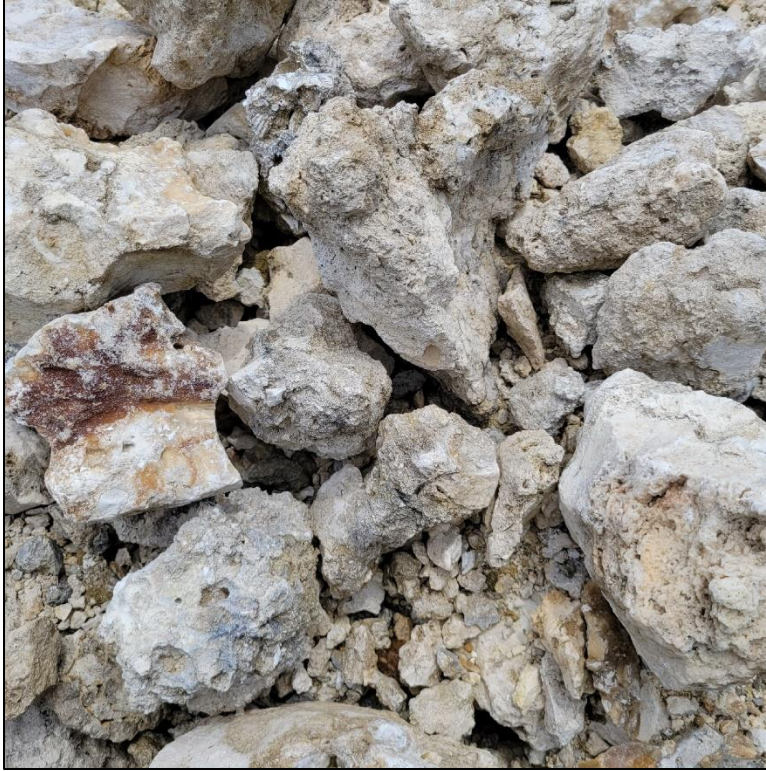
Photo 34: Quarried rock (July 2023)

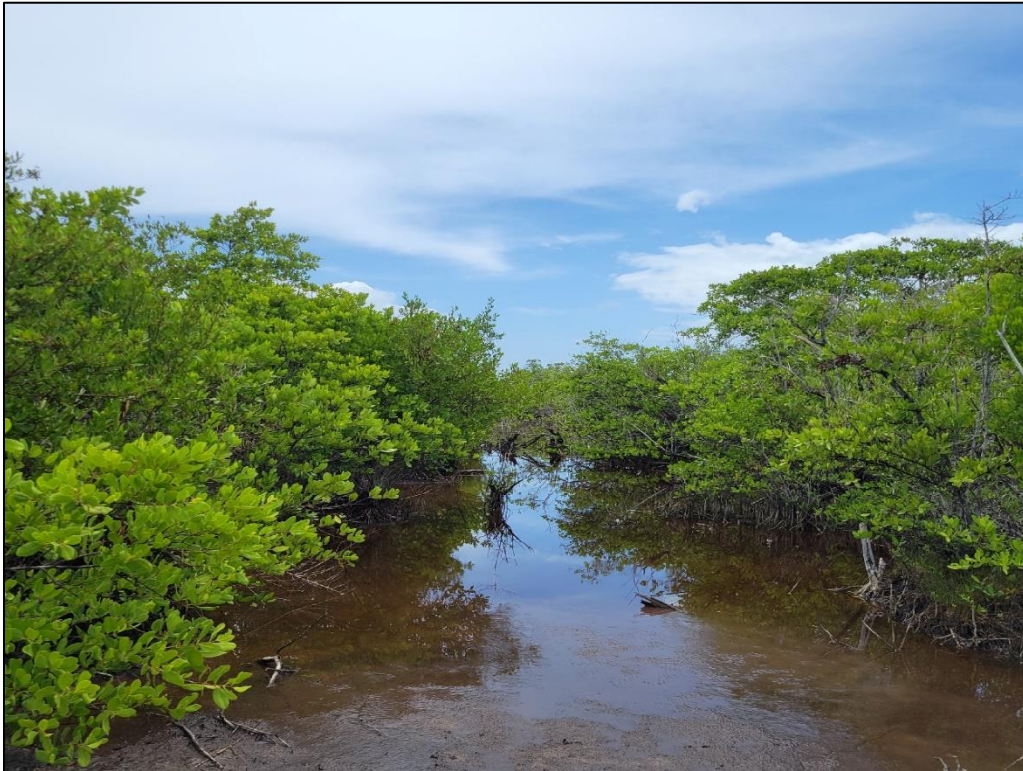
Photo 35: Peat in mangroves north of quarry (July 2023)
